Potential Interference with Cutting Unit Pitch Arms and Roll Frame

Product: Greensmaster Flex 1820/2120

February 26, 2016

Subject: Potential Interference with Cutting Unit Pitch Arms and Roll Frame.

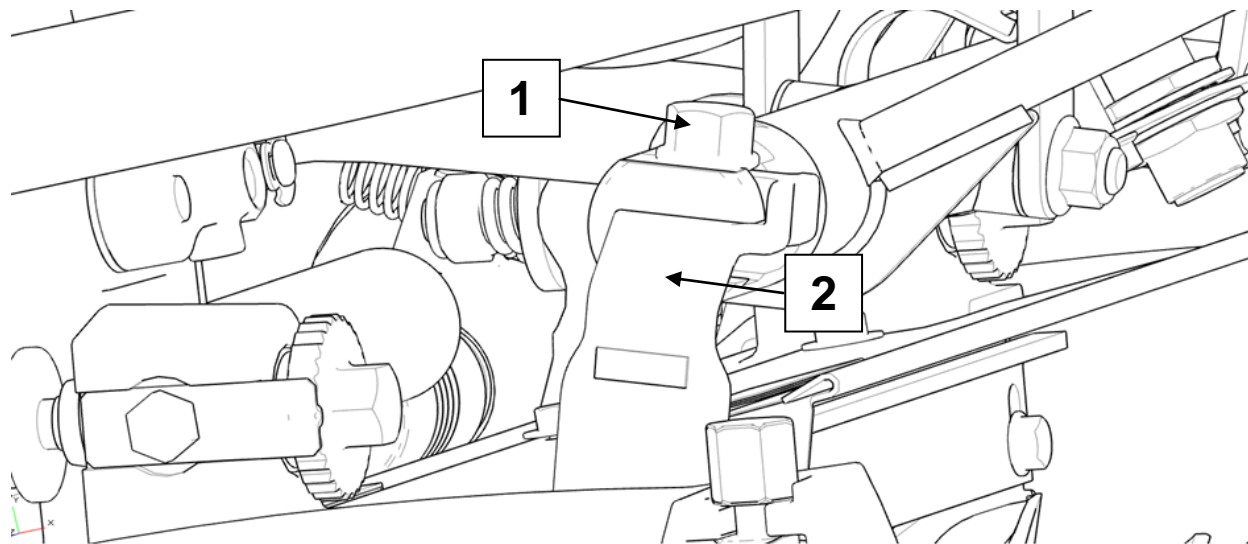
Figure 1

When installing specified early 2016 or 2015 and earlier Flex 1800/1820/2100/2120 cutting units on MY 2016 Flex 1820/2120 traction units, the roll frame bolts may interfere with the cutting unit pitch arm tabs. This interference will be apparent when securing the cutting units to the roll frame. See Figures 1 and 2 for specific information about where the potential interference points exist.

1. Roll frame bolt head
2. Pitch arm assembly (R/H side)

Mount the cutting unit and inspect for interference. If interference exists, remove cutting unit pitch arm material by grinding a 45-degree chamfer (2.28 mm/.090 inch) to both pitch arm tabs around the head of the fastener as shown in Figures 1 through 4. This will allow adequate clearance around the fastener to allow the fastener head to sit flush against the pitch arm tab and properly secure the cutting unit to the traction unit. Once modifications are complete and clearance exists between the bolt head and the pitch arm assembly, cover the chamfered area with Toro red touch up paint as required.

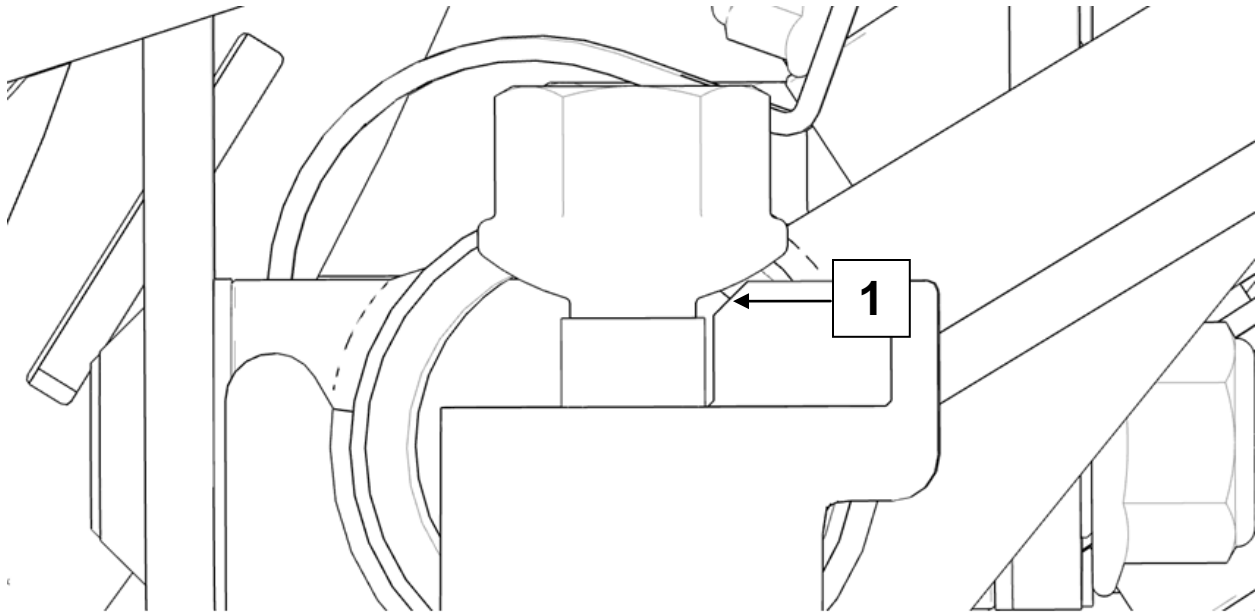
Figure 2

1. Side view with 45-degree chamfer

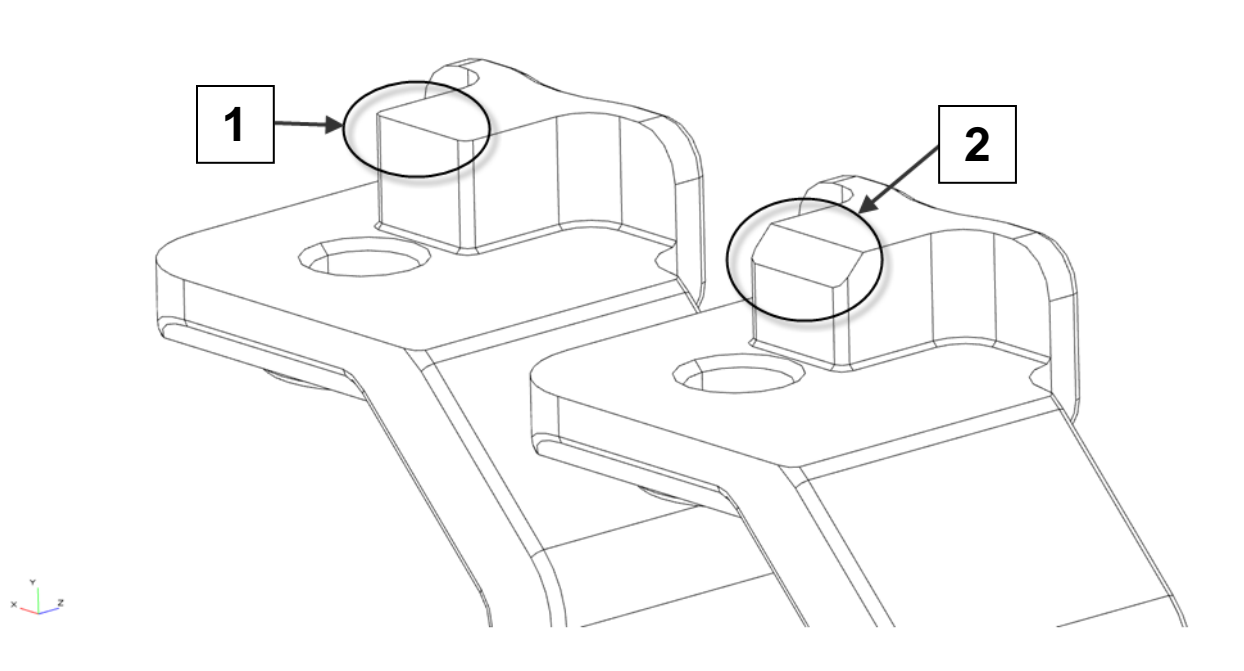
Figure 3

1. Early 2016, 2015 and earlier cutting unit and pitch arm assembly
2. Current 2016 cutting unit pitch arm assembly
