Customer Bulletin

Stainless Steel Sprayer Pump Heads Multi Pro Sprayers

Bulletin Type Information Only

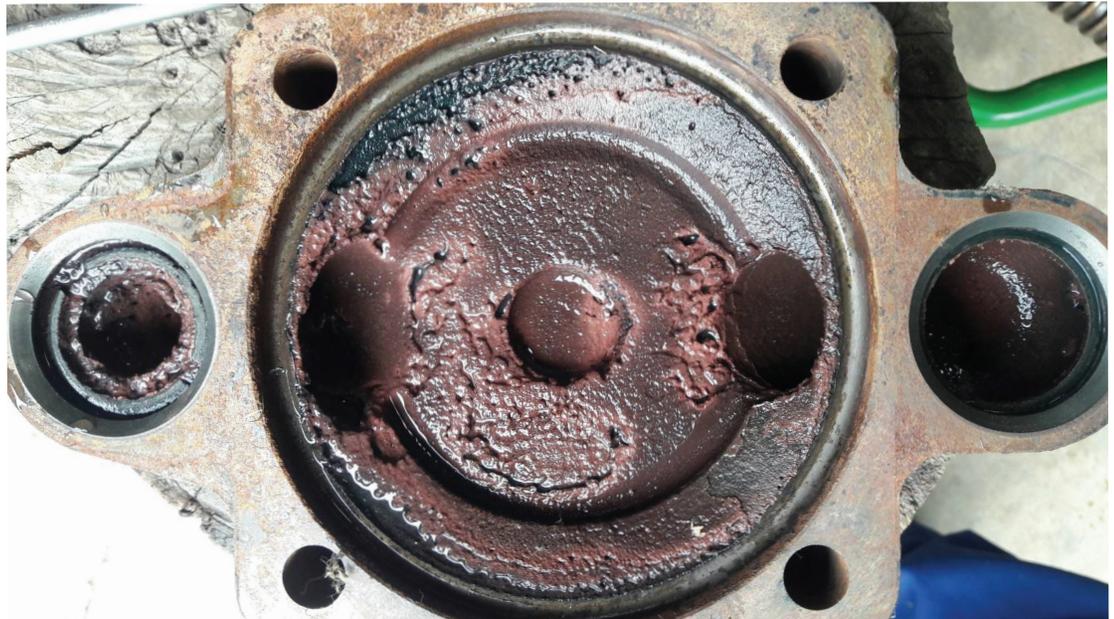
Figure 1

Corrosion and wear leading to premature pump head failure has been reported on some 6-piston spray system pumps.

Material wear can be attributed to 3 causal areas.

Improper rinsing and neutralizing can cause residual chemicals left in the diaphragm system to drain down and collect in the pump heads at the bottom of the pump. These chemicals degrade the internal surfaces.

Cavitation can be a leading cause of pump head and diaphragm failure. When the suction is restricted, this can cause excess vacuum that will introduce air into the pump inlet. When these air molecules change from a vacuum state to a pressure state in the pump, they will cause damage to the surrounding surface area.

Heavy abrasives and corrosive mixtures (i.e., iron or copper-based products and salts) can accelerate the material wear of the pump and pump heads. It is known that heavy iron usage can lead to premature pump wear.

Customers who have experienced historical failures of spray pump heads are encouraged to purchase stainless steel spray pump heads as they are more resistant to chemicals such as iron and copper. Maintenance, cavitation, and corrosion will still be a threat to deterioration of the material surface and due diligence is still required in adhering to proper maintenance practices (i.e., rinsing and neutralizing).

Part replacements should be done as a set. Do not mix the older style pump heads with the stainless steel pump heads to avoid potential repeat pump head failures. Doing so will cause pump head interference and will not allow pump head to fully seat correctly.
