Potential Steering Hardline Contact with Engine Oil Cooler

Product: Groundsmaster® 4300

April 19, 2017

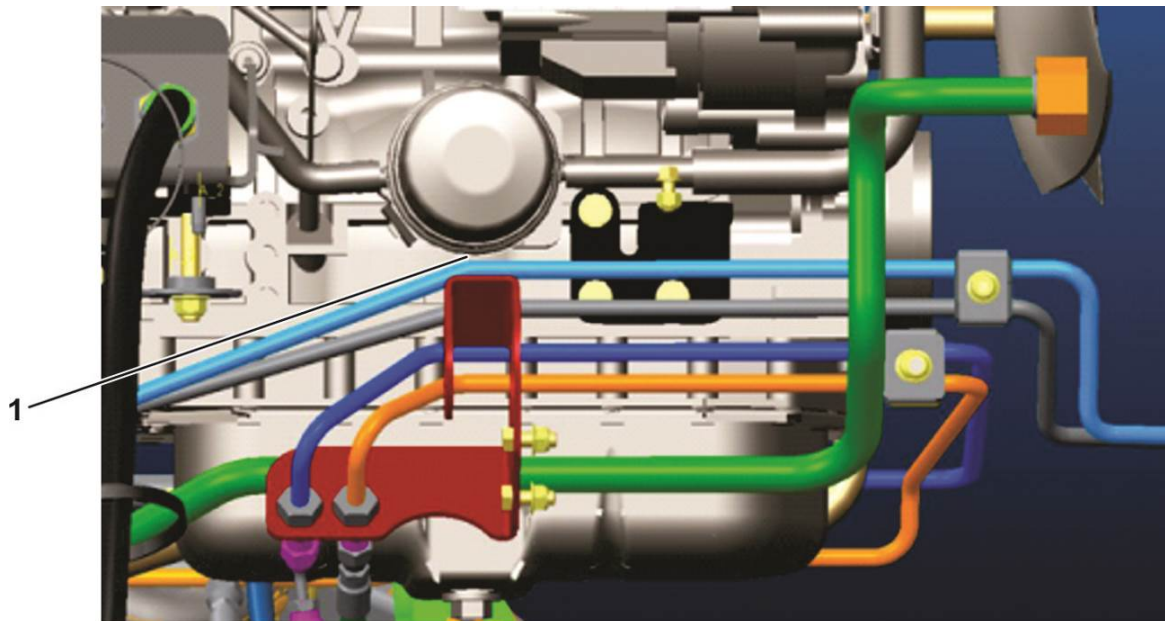
Figure 1

A steering hard line could contact the bottom of the engine oil cooler. If this contact continues, the steering hard line will wear and may ultimately fail.

Area to check for adequate clearance ($\frac{1}{4}$ " or 6 mm) between hard line and

During maintenance, inspect the area near the engine oil filter/cooler to ensure there is ample clearance between the cooler and the steering hard line. If the hard line is contacting the engine oil cooler, bend the line down, away from the cooler until it clears. Inspect the hard line for any damage that could result in failure.
