General Product Information

All product equipped with Dana GT 20 Differentials:

Subject: Repair suggestions for Dana Axle Shaft Seal leakage conditions.

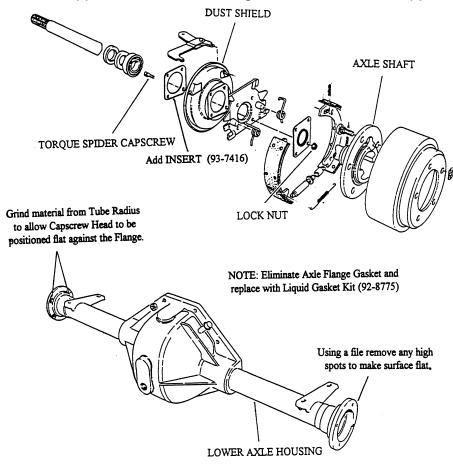
To ensure the greatest possible long-term success with a repair, certain enhancements should be considered in addition to the replacement of any failed parts. Refer to the instructions and diagrams below.

- 1. The head of the Torque Spider Capscrew must be positioned flat against the Axle Flange. To accomplish this, grind any material from the Axle Tube radius that interferes with the edge of the cap screw head.
- 2. The outside surface of the Axle Flange must be flat. Use a file to correct any high areas.
- 3. Eliminate the Axle Flange Gasket and replaced with Liquid Gasket Kit (92-8775).
- 4. Add metal Insert (93-7416) between the Dust Cover and the Axle Flange. This Insert will provide additional support to the Axle Bearing for extreme side hill applications.
