Greensmaster® 3250-D

04383 20000001-210000600

Subject: Breather Tube Replacement Prevents Engine Damage

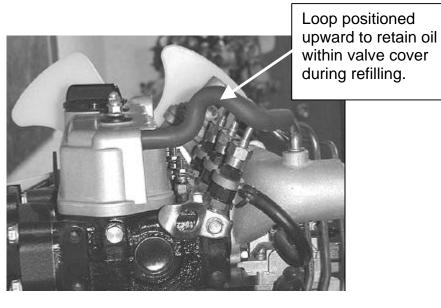
When refilling or "toping up" engine oil, if the oil is added too rapidly, the oil level in the valve cover chamber may rise above the breather tube outlet. If this condition occurs, clean oil may be ingested into the cylinders, via the intake manifold, which may result in hydraulic lock and can cause serious engine damage.

To prevent this from occurring, install a new Breather Tube (104-7743) on all products listed above. This tube has a molded loop that is positioned upward to prevent oil from flowing into the air intake manifold.

- 1. Remove the old breather tube connecting the intake manifold to the outlet on the valve cover.
- 2. Install new Breather Tube with loop oriented upward as shown below.
