Customer Service Bulletin Commercial Business Group

Greensmaster® 3050 and 3100

<u>Model/Serial Range:</u>	<u>Model Number:</u>	<u>Serial Numbers:</u>
	04351	80001-89999
	04353	80001-89999
	04354	80001-89999

Subject: Mow Function Stops During Mowing.

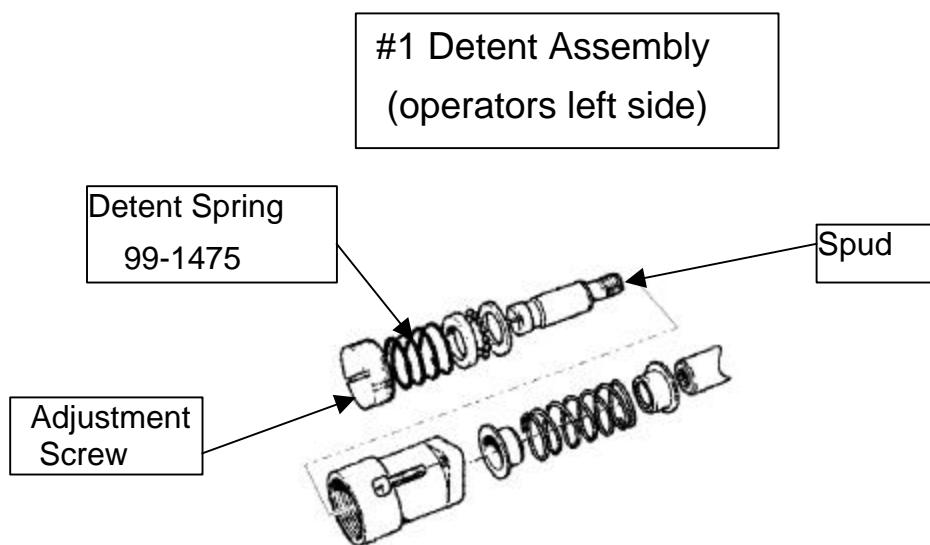
The reel drive system on the units listed above may disengage when it should not. This may be caused by an incorrectly adjusted mow detent, incorrectly adjusted valve linkage, or mow pedal interference with the frame. If these items are inspected and found to be correct, the problem may be remedied with the installation of a stronger Detent Spring (99-1475) Repair steps follow.

1. Remove the Adjustment Screw from the #1 (operators left side) valve spool
2. Remove the Detent Spring.
3. Install new Detent Spring (99-1475) and partially install Adjustment Screw.
4. Apply 2 drops of blue Loctite® to threads of Adjustment Screw.
5. With the engine off and valve bank in the mow position, tighten the Adjustment Screw until foot force required to operate lift pedal (disengage mow detent) is adequate. Do not tighten adjustment screw too tightly as this could bind the spool. Verify unit operation.
