Customer Service Bulletin Commercial Business Group

Greensmaster® 1000 and 1600

Subject: Drive System becomes affected when Clutch Lever Stop bends.

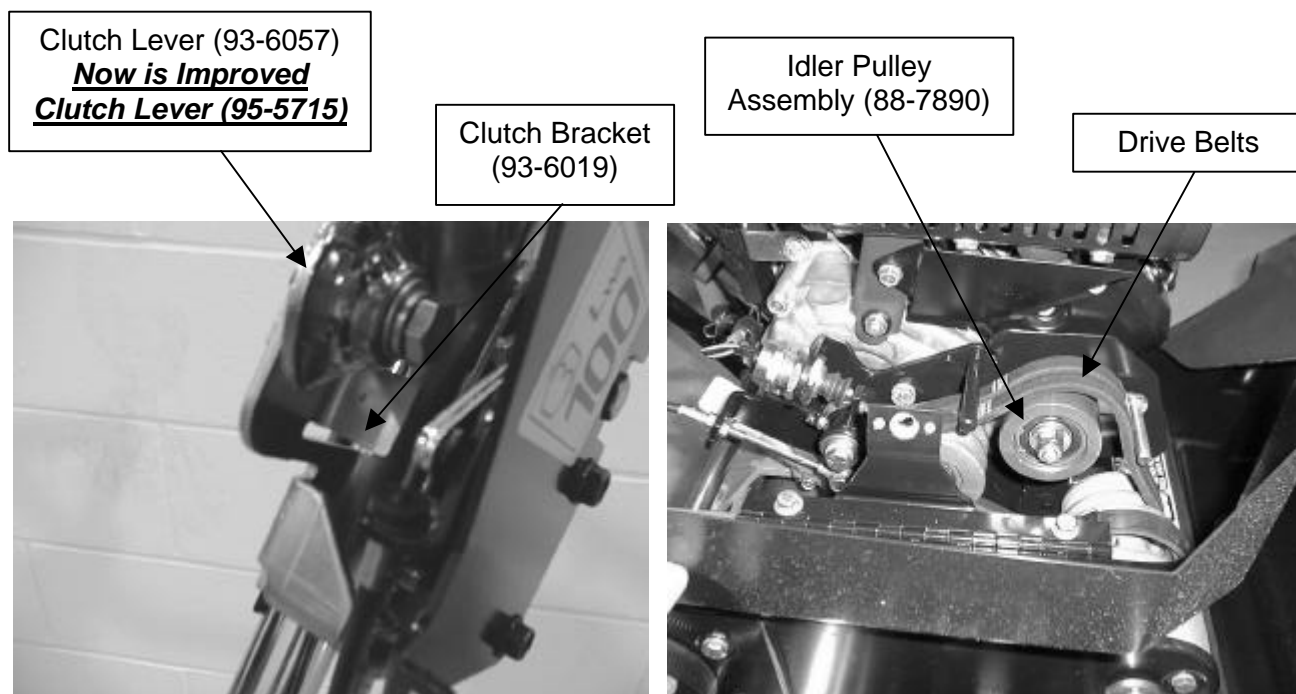
The stop tab on Clutch Bracket (93-6019) can bend if the operator uses excessive force to engage the Clutch Lever. A bent stop will allow the clutch lever to over-travel and cause the Idler Pulley to partially disengage the drive belts. A bent stop can result in drive belt slippage, accelerated belt wear, or poor drive system performance.

To help prevent the operator from using excessive force, Clutch Lever (95-5715) is now available for installation. The pivot location of the improved Clutch Lever has been relocated to lessen the forces that can be generated at the stop tab. The pictures below are provided for reference purposes. Contact your local Toro distributor if assistance with this repair is needed.

Note: We recommend replacement of Clutch Bracket (93-6019), if the stop has been bent.
