Greensmaster[®] Flex 21

Date:12/20/01

Model/Serial Range:	Model Number:	Serial Numbers:
	04021	210000001-210000889

Weak Traction Climbing Hills or Trailer Ramp Subject:

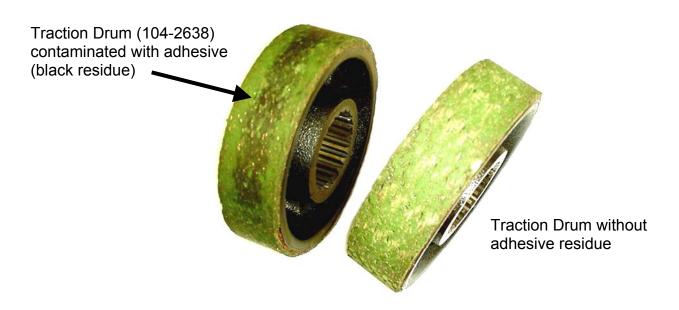
The friction surface of Traction Drum (104-2638) in the gearbox of some units may have been contaminated with bonding adhesive when the part was manufactured. The presence of this adhesive (see below) can reduce the traction performance of the machine and may prevent it from climbing a slope or a trailer ramp. Contact your local Toro distributor for assistance, if required.

- 1. Install Wheel Kit (04122) to elevate the severity of the test.
- 2. Verify the Traction Cable (traction only) is adjusted to specification (12-16 lb. of force). Use a spring scale attached to the control lever for this test.
- 3. Start the unit and partially engage the traction lever to generate internal slippage/heat for 20 seconds.
- 4. Position the unit at the bottom of a 15 degree ramp (e.g. TransPro trailer).
- 5. Attempt to drive the unit into the trailer by feathering the traction lever. If the unit does not climb into the trailer, replace the Traction Drum.
