# BEARING CAP MODIFICATION INSTRUCTIONS

## Reelmaster® 3100-D Sidewinder

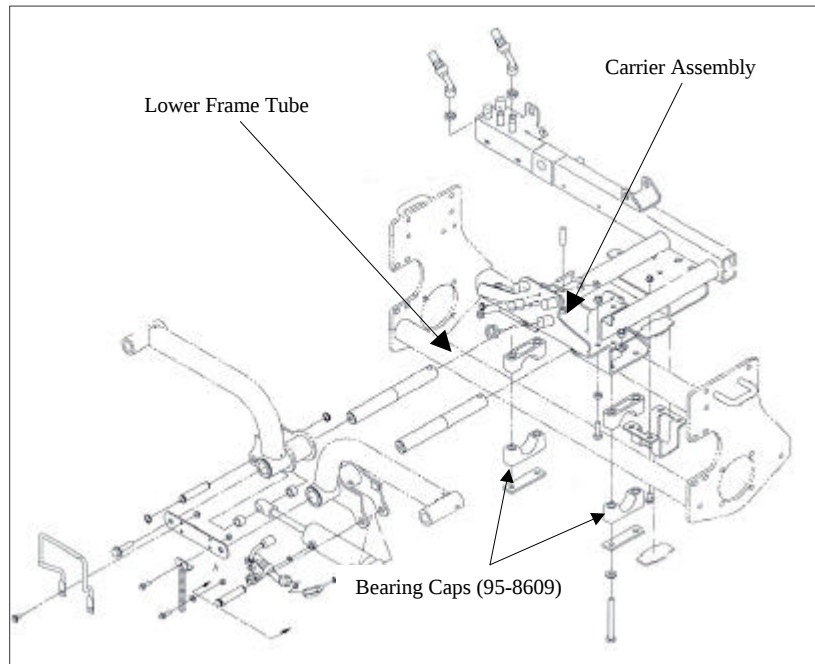
**Fig. 1**

The Reelmaster 3100-D Sidewinder machines listed above were produced with 2 sets of Bearing Caps to allow side-to-side movement of the Carrier Assembly. These Bearing Caps were designed to be a wear component that requires periodic replacement. In some applications or environments, wear may occur earlier than expected.

**Note:** Wear occurs on the Bearing Cap, not on the Lower Frame Tube. The Lower Frame Tube will show signs of the paint wearing or scrubbing off the tube. This type of wear is considered normal.

1. Before proceeding with repair, stop engine and remove the key from the ignition switch.
2. Drill four .531" (17/32") (13.5mm) holes inboard of existing holes on the Carrier Assembly. See layout in Fig. 2.
3. Install Bearing Caps (95-8609) and related hardware to Carrier Assembly.

**Note:** You can also use the new Bearing Cap as a template to mark the holes to be drilled. Simply position the new Bearing Cap ¼" (6.4mm) to the inside of existing Bearing Cap and mark the holes for drilling.
