Customer Service Bulletin Commercial Business Group

Reelmaster® 5500-D

Subject: Oil from the differential can transfer to the hydraulic system on some units.

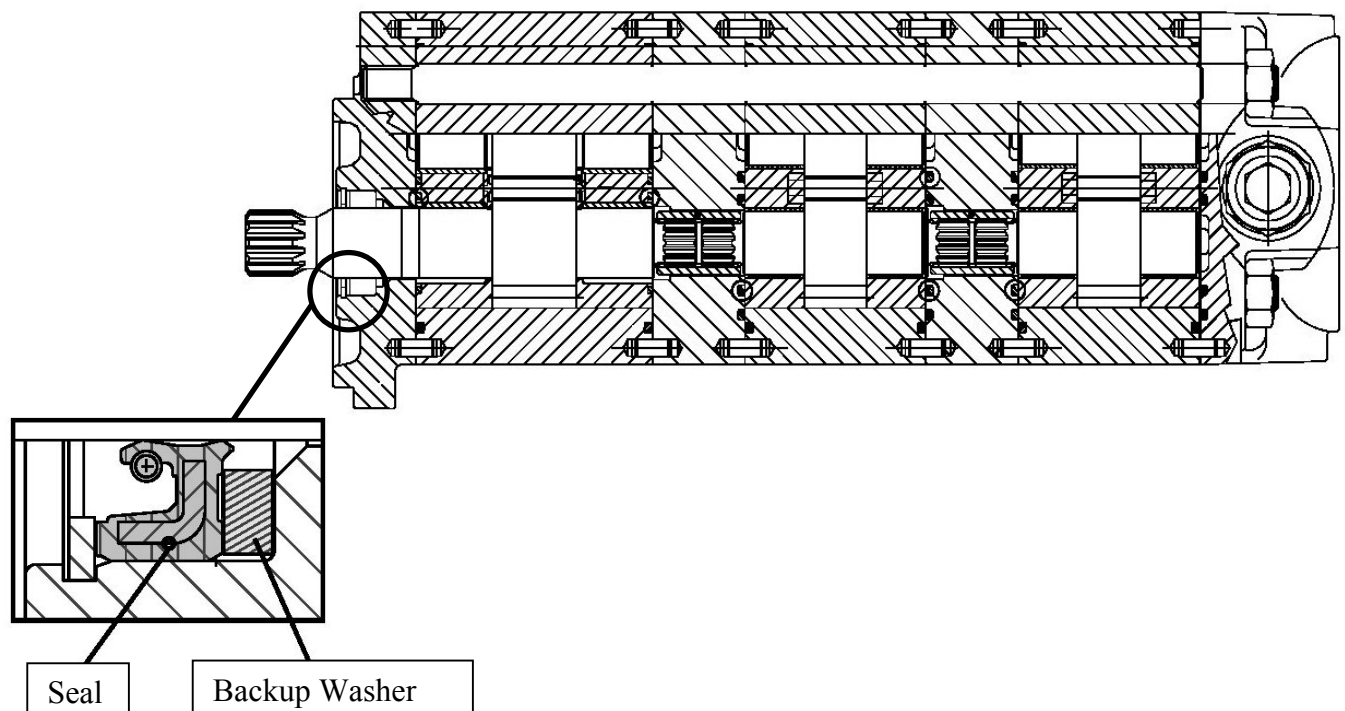
There have been instances where the differential oil is low at the same time the hydraulic system is overfilled. Investigation has revealed that in some instances oil has transferred from the differential to the main hydraulic system. The exact circumstances allowing this to happen to a very small percentage of units are unclear, but it is known that the transfer happens past the seal of the sectional pump.

Should you find that oil in the differential is low and the hydraulic system is overfilled, add or remove oil to correct the fluid levels. Run the machine for a 50-hour period and recheck the levels. If the level in the differential is again low while the hydraulic level increases, replace the sectional pump seal using Seal Kit (104-0576). The seal in this kit will be installed with a backup washer behind it and the lip facing out. Refer to figure below for more information regarding seal orientation.
