Customer Service Bulletin Commercial Business Group

Reelmaster[®] 5, 7, & 11 Blade Reel

<u>Model/Serial Range:</u>	<u>Model Numbers:</u>	<u>Serial Numbers:</u>
	01005	200000101-210000249
	01007	200000101-210000932
	01011	200000101-210000251

Subject: Ring Gear Hub (95-1828) Leaks Gear Oil.

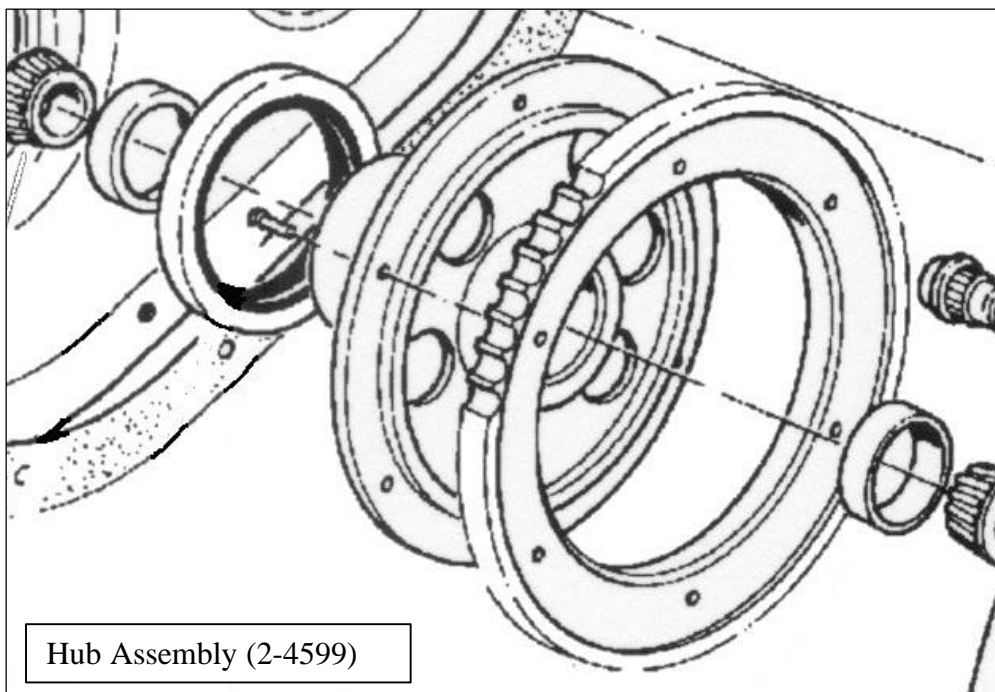
The holes used for attaching the wheels to the mower may have been machined incorrectly. This condition has been found to cause gear lubricant leakage due to improper sealing of the wheel.

If the four tapped bolt holes in the Ring Gear Hub (95-1828) have been drilled short of the specified minimum 0.687" (17.5 mm) depth, the wheel will not seat fully. In addition, these holes may have been tapped for 8 mm diameter bolts rather than 5/16-18 NC thread required; the threads could be damaged.

Contact your Toro Commercial Distributor if either of these conditions are found.
