Customer Service Bulletin

Reelmaster® 6500/6700-D

Subject: Importance of Routine Reel Drive Hose Inspections.

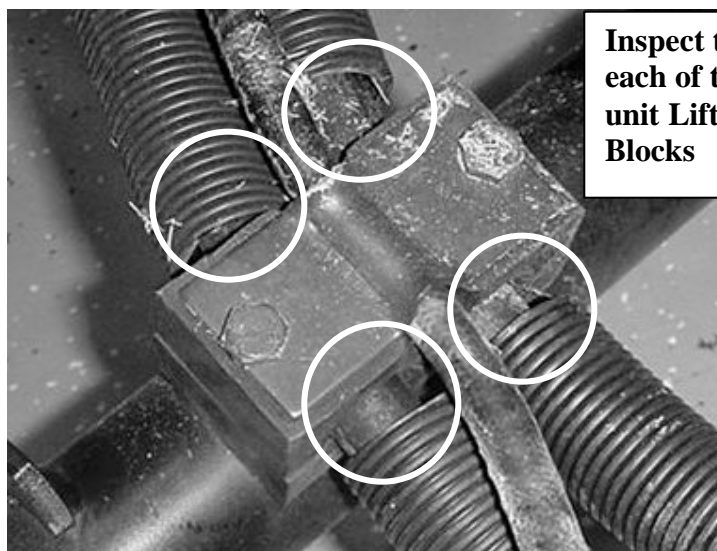
As an added note of caution, the reel motor hoses can develop pinhole leaks at the rubber Clamp Blocks on the front 3 lift arms. While the Clamp Blocks are designed to allow hose movement during normal lifting and lowering of the cutting units, if the Clamp Block retainer Screws are too tight the Blocks can compress and restrict hose movement. This can strain the hoses at the blocks and lead to hose leaks.

Inspect the circled areas on each of the front 3 cutting unit Lift Arm hose Clamp Blocks

Daily hose inspections on the front 3 cutting unit lift arm hose Clamp Blocks should be performed on all machines. If any of the hoses shows signs of leakage or blistering of the outer covers in the areas of the Blocks, hose replacement is required.
