Customer Service Bulletin

Reelmaster® 2300 and 2600

Subject: Lift Arm has excessive fore and aft movement.

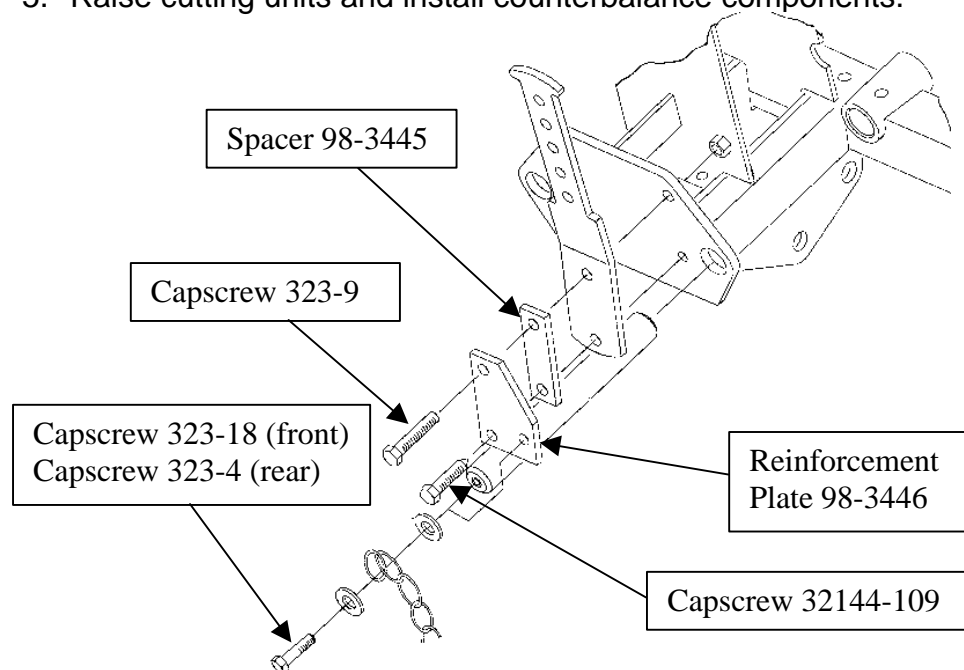
Some units may develop excessive wear at the lift arm pivot pin allowing excessive forward and rearward movement of the Lift Arms. If the lift arms become excessively loose, install the parts shown below to reinforce this area. Parts are available through your local Toro distributor.

1. Raise cutting units and disconnect all counterbalance springs.
2. Lower cutting units to ground and remove ignition key.
3. Remove and discard three original fasteners shown below.
4. Install new fasteners through Reinforcement Plate and Spacer as illustrated.
Note: Mount the short side of the reinforcement plate onto the pivot pin.
5. Raise cutting units and install counterbalance components.
