## Customer Service Bulletin Commercial Business Group

### Reelmaster® 6500/6700-D

**Subject: Rear two Cutting Units (under-engine) Raise and Lower Too Fast.**

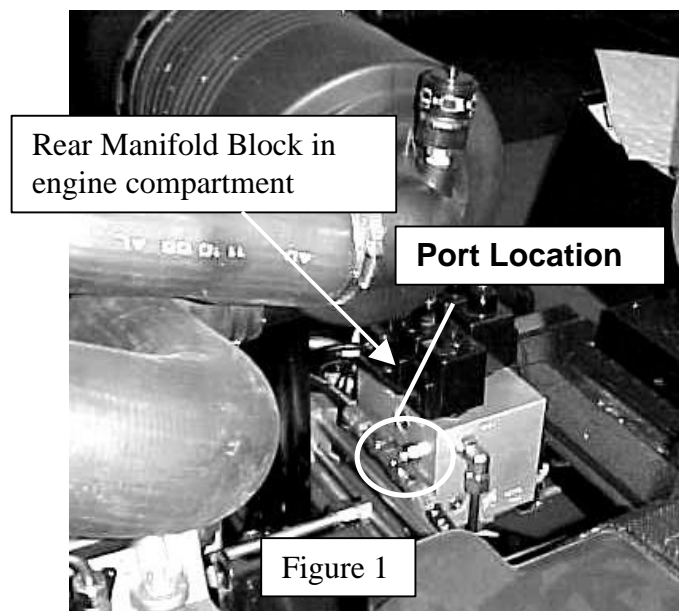
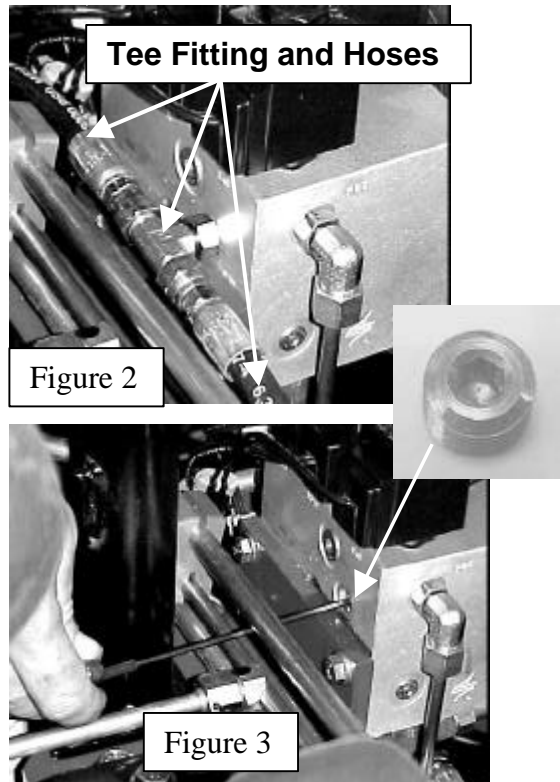
Beginning with the 2000 model year product, the cutting unit hydraulic lift system was changed from a series system to a parallel system. Since parallel systems split oil flow and reduce the speed of lift and lower, the control orifice was removed from this circuit. Because of these changes, some tractors may seem to raise the two rear “under-engine” cutting units (#2 & #3) too fast and hit the tractor frame abruptly.

**Note:** The Port is marked **C3B on RM 6500**, and **C2B on RM6700** (Fig. 1).

A screw-in, fixed (non-adjustable) Orifice (94-2626) can be installed into the rear Manifold Block that will reduce the raise/lower rate of the 2 under-engine cutting units.

To install, turn on key and lower the cutting units to the ground. Remove the 2 hydraulic hoses and Tee Fitting at the rear Manifold Block as shown in Figure 2. Install Orifice (Fig. 3) using a 1/8" Hex wrench. Re-install the Tee Fitting and hoses.
