Groundsmaster[®] 455-D

Model/Serial Range: Model Number: 30450 30455 Serial Numbers: 50146-50180 50215-50381

Subject: Wing Deck Belt slippage and wear.

Ref: 14-06 Copyright^{\circ}, 1995. The Toro Company

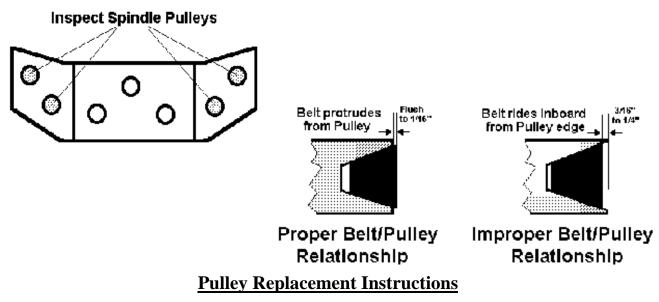
The Wing Deck Blade Spindles on the units listed above may have improperly manufactured Drive Pulleys installed. The incorrect Pulleys have a larger belt groove, which allows the Belt to ride too deep in the Pulley. This may cause accelerated Belt wear, Belt tensioning problems and quality of cut issues. The pulleys can be inspected using the instructions below. Replacement parts are available through your local Toro distributor.

Visually inspect each of the Wing Deck Blade Spindle Pulleys (4 per Cutting Unit). Compare the drive Belt-to-Pulley groove position against the diagram below to determine if the Pulley requires replacement. Pulley replacement instructions are listed below.

- 1. Remove Belt tension from the Self-tensioning Spring loaded Idler. Remove the drive Belt from the Spindle Pulley to be replaced.
- 2. Block the Spindle Blade from rotating by using a large block of wood under the Deck and remove the Pulley retainer Nut with a socket or wrench.
- 3. Slide incorrect Pulley from Spindle Assembly and install Pulley (86-1700).
- 4. Re-install Nut and torque to 150-170 ft/lbs (20.7-23.5 KgM). Unblock Spindle and rotate to ensure free movement.
- 5. Install Belt and reset Self-tensioning Spring loaded Idler to proper specifications (listed on Decal).
