Customer Service Bulletin Commercial Business Group

Groundsmaster® 455-D

<u>Model/Serial Range:</u>	<u>Model Number:</u>	<u>Serial Numbers:</u>
	30450	20001-69999
	30455	20001-69999

Subject: WING DECK DRIVE BELT JUMPS OUT OF PULLEYS.

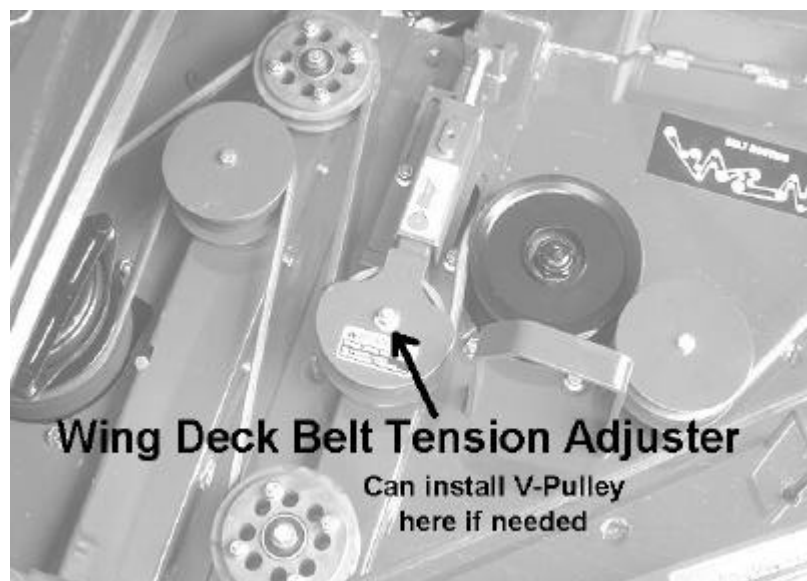
The wing deck belt drive system on the Groundsmaster 455-D is designed to allow flexible operation over ground contours. Impacting large objects, which abruptly stop blade rotation, may induce slack in the belt and allow it to jump out of the pulleys. Spindle or idler pulley bearing damage, belt tension adjuster spring damage, pulley centerline misalignment or a defective wing deck Safety Switch can also contribute to belt jumping.

If your inspection fails to identify the cause of the belt jumping, V-Idler Pulley (92-9721) is available for installation in the Wing Deck Belt Tension Adjuster. The V-Idler Pulley will provide improved belt tracking on the Wing Deck and reduce chances of belt jump during operation.
