Workman® 3000 and 4000 Vehicles

Subject: Proper Drive Shaft greasing procedures.

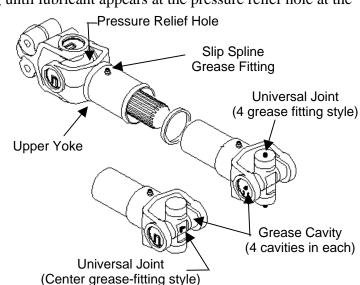
—Pressure Relief Hole

3. Apply grease gun pressure to the fitting until lubricant appears at the pressure relief hole at the upper yoke on the drive shaft.
