Customer Service Bulletin Commercial Business Group

Greensmaster® 3050 and 3100

April 2, 2002

Subject: Evaluating Mow Valve Detent function.

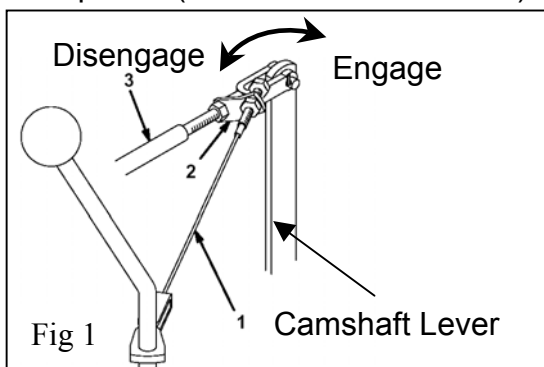
1. Disconnect the clevis from the Camshaft Lever. It is not necessary to disturb the rod or cable adjustments (items 1, 2, and 3 in Fig 1).
2. Use the Camshaft Lever to manually engage the detent (pull sharply rearward).
3. Attach a spring scale to the hole in the Camshaft Lever (perpendicular to lever) and note the force required for the detent to disengage (pull forward). Turn the slotted adjustment cap on the front of the valve IN (clockwise) to increase and OUT (counter-clockwise) to decrease the disengage force. If a consistent disengage force of 25 lbs (11.4 kg) cannot be obtained, the detent must be cleaned, lubricated, or repaired (refer to Service Manual).

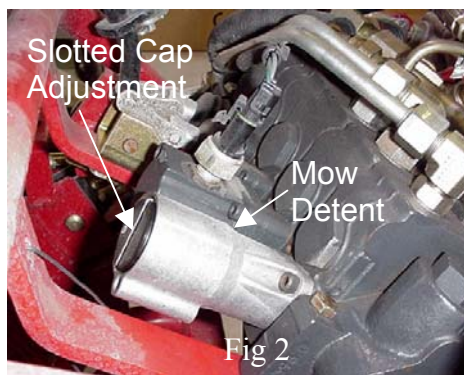
Note: The cap adjustment will be approximately 1 full turn out from a fully bottomed condition if the detent is in the first Valve Section (as shown in Fig 2), or 1½ turns if it is located in Section 2 of the Valve Assembly.
