## Customer Service Bulletin Commercial Business Group

### Reelmaster® 5000 Series

#### **Subject: Front Axle Seal Leakage.**

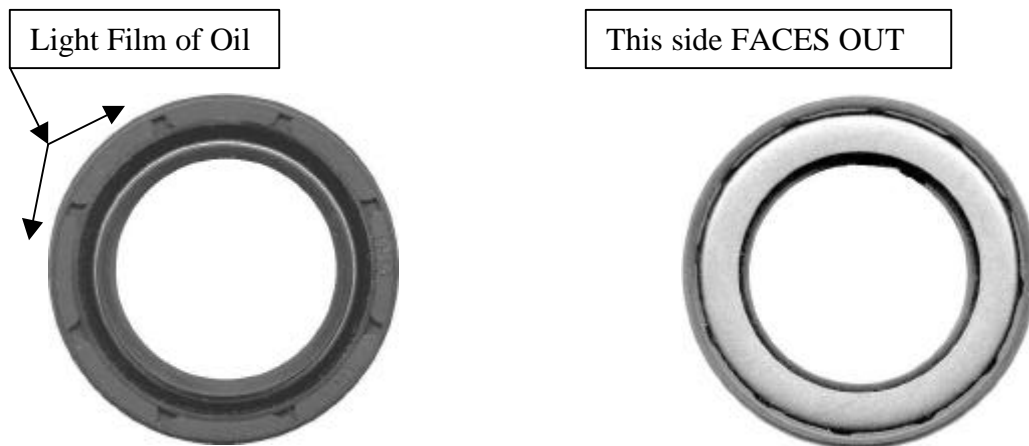
Front axle seal leaks may be due to flexing of the axle shaft during periods of extreme loading. When the axle shaft flexes Seal (92-1774) may not be able to maintain contact around the entire circumference of the axle shaft. If this occurs, under some conditions, small amounts of oil can escape. Wheel bearing failure may also result if the oil dilutes the grease in the wheel bearing.

Axle Seal (99-6969) has been improved to maintain contact with the axle shaft when flexing occurs. Axle Seal (99-6969) should be used whenever repairs to the front axle are performed on any unit listed above. The seal should be installed in accordance with the service manual and should be installed with the metal insert facing outboard. Coat the outer diameter of the seal with a light film of oil during installation. A light film of oil applied to the outer surface will ease installation and help prevent damage to the rubber surface of the seal.
