Customer Service Bulletin Commercial Business Group

Greens Aerator

Subject: **Hole quality concerns.**

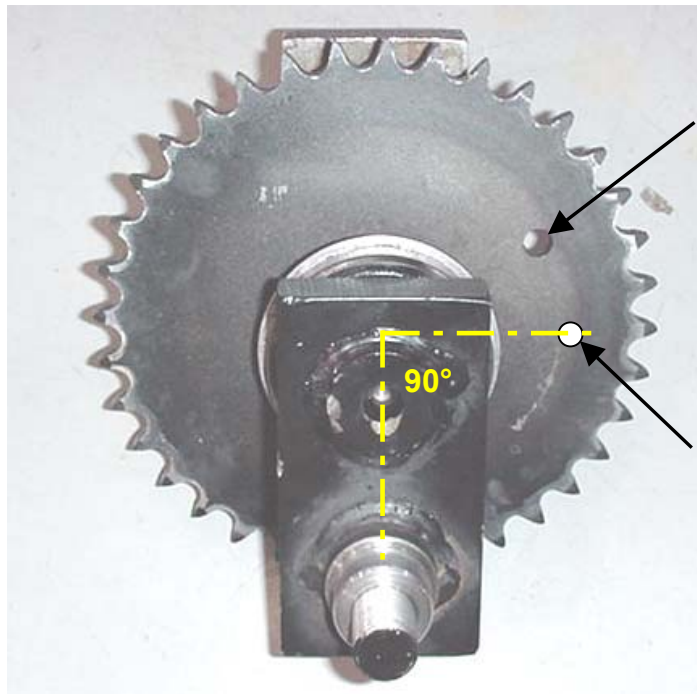
An incorrectly welded crank arm (Short Crank Assembly 66-4040 or Long Crank Assembly 66-4030) may affect timing and be responsible for poor hole-quality.

The picture below will help identify a crank assembly that is made wrong. The timing hole should be in a 90-degree position to the crank pins as shown. An incorrect crank assembly should be replaced. Contact your local Toro distributor for assistance.

Incorrect position of timing hole shown.

Correct position of timing hole is 90 degrees to crank pin.
