ProCore[®] 440, 660 and 880 AeratorsDate: May 12, 2003

Subject: Rotalink Arm damage and loose Rotalink Element.

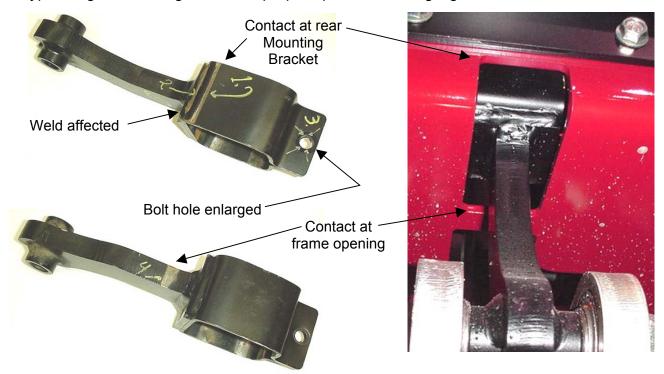
The Rotalink Arm may become damaged or distorted due to improper operating techniques resulting in a loose Rotalink Element. Damaged Rotalink Arms and loose Rotalink Elements may result in poor hole-quality. The key factors below are covered in the Operator's Manual and Operator's Video (Tape 01087SV or CD 02096SD).

- Always disengage the PTO or lower the engine speed to idle before raising the aerator. Never operate the coring head in the air at full speed. The uncontrolled Tine Arm mass will cause the Rotalink Arms to make heavy contact with the frame opening and mounting bracket. The Rotalink Arms will only withstand a limited amount of this abuse before damage occurs.
- 2. Select the proper tractor gear and control downhill tractor speed to prevent exceeding the maximum 2.5 mph (4 km/hr) coring speed. Exceeding the maximum recommended speed while coring will over-run the coring operation. Doing so can result in the Rotalink Arm making heavy contact with the framework as the tines fail to clear the turf soon enough.

Typical signs of damage due to improper operation are highlighted below.
