Customer Service Bulletin Commercial Business Group

Groundsmaster® 4000 Series

Date: May 5, 2003

Subject: Difficult Engine Starting After Extended Periods of Non-Use.

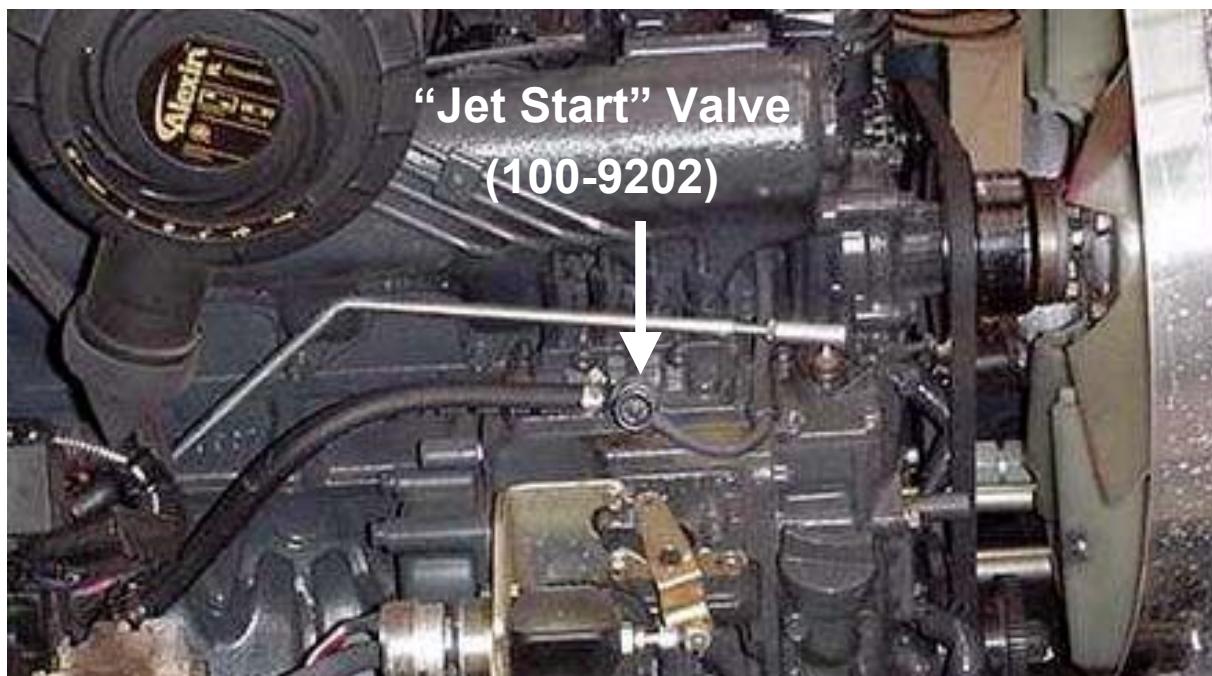
The Kubota 2003T engine used in the Groundsmaster 4000 Series Tractors have been reported as difficult to start, exhibiting excessive crank time, or producing excessive white smoke. It also can run rough for the first few minutes of operation. The listed units may exhibit objectionable starting behavior after extended periods of non-use (overnight or after sitting idle all weekend). This may be caused by air leaking into the fuel supply circuit.

To correct this issue, slightly open the "Jet Start" air bleed valve located on the injection pump assembly. The valve should only be opened from the closed position 1/10th to 1/8th of turn maximum. This adjustment will allow any accumulated air in the system to be purged by the low-pressure fuel transfer pump during the initial glow cycle. The Jet Start Valve should be left in this position at all times during normal operation.
