Customer Service Bulletin Commercial Business Group

Workman® 4000 Series

Subject: Noisy Front End.

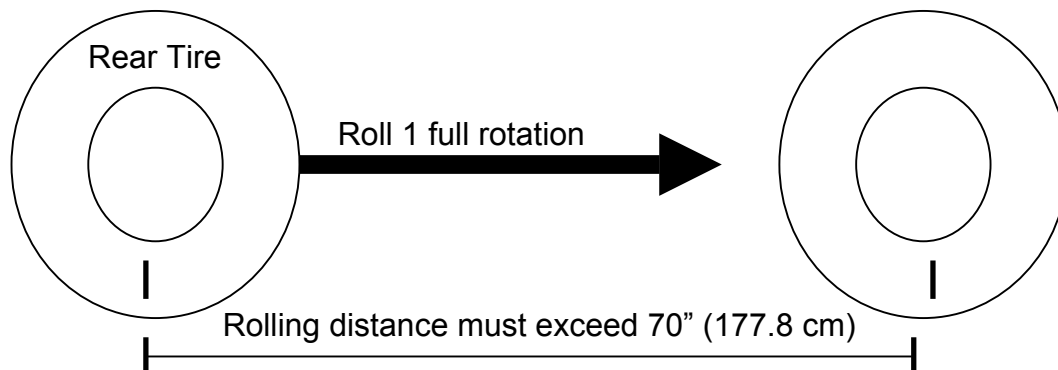
1. Inflate all tires to 18-20 psi. (1.2 – 1.4 bar) Park the unit on a hard surface and place a mark (with adhesive tape or chalk) on the sidewall of the rear tire where it contacts the ground (the 6 o'clock position).
2. Place a mark on the ground corresponding to the mark made on the tire, create another mark on the floor 70" (177.8 cm) ahead of the original mark on the ground, or lay a tape measure on the ground for that distance.
3. Drive or push the vehicle forward until the marked rear tire completes one full rotation. The mark on the tire sidewall should be equal or be beyond the forward mark (70" or 177.8 cm) on the ground after one full rear tire rotation.
4. If the mark on the tire measures anything less than 70" (177.8 cm) when in the 6 o'clock position after one full rotation, the rear tires should be replaced with Turf Trak Tires (87-6740).
