## Customer Service Bulletin Commercial Business Group

### Groundsmaster® 3500-D

Date: September 29, 2003

**Subject:**    **Lift intermittently fails to hold, allowing cutting units to fall.**

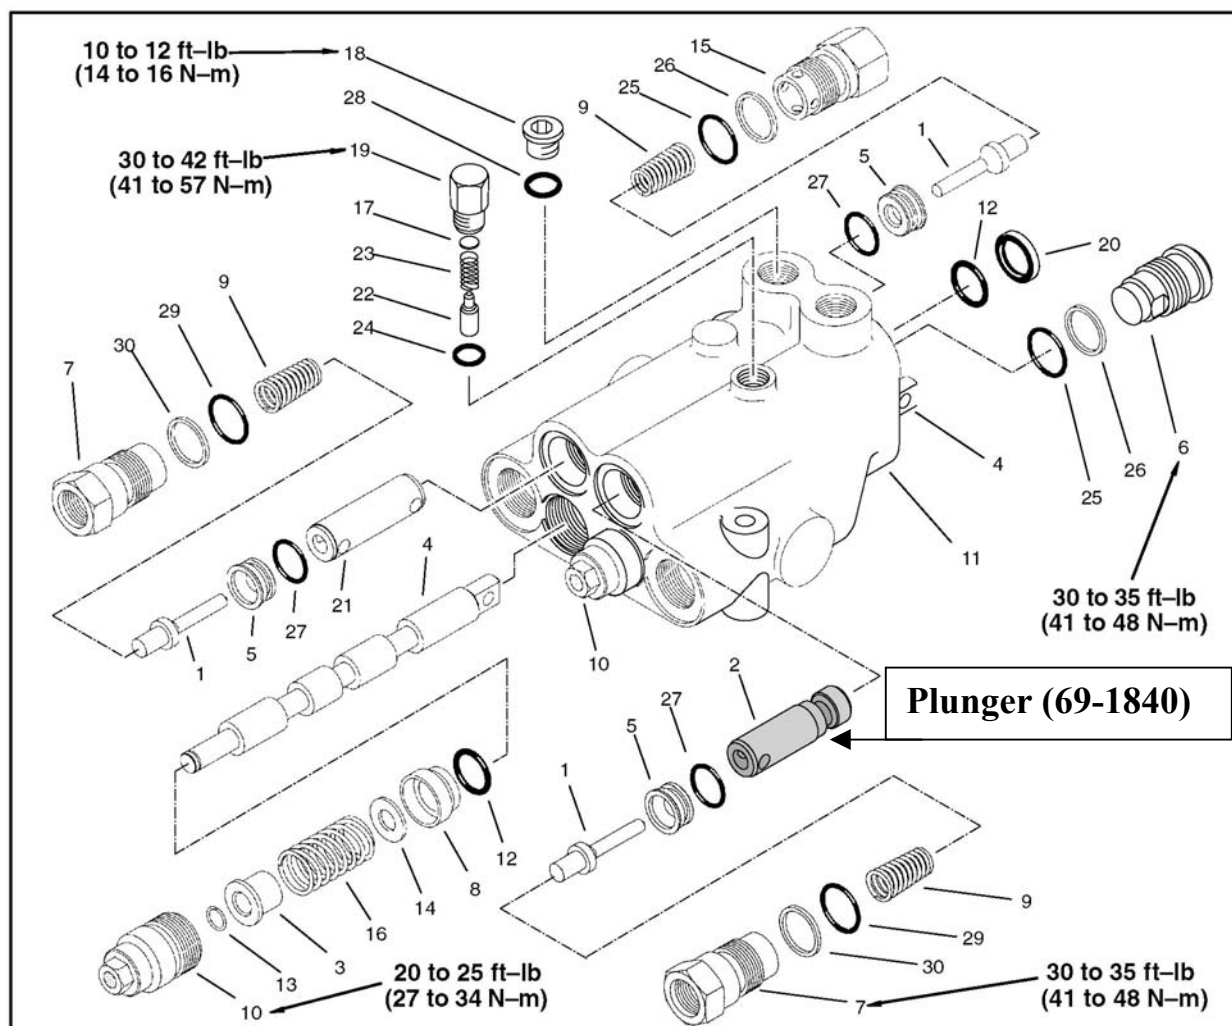
The Plunger (69-1840) in Control Valve Assembly (95-8581) may have been machined improperly. An improperly machined plunger may intermittently allow the cutting units to drop as soon as the lift handle is released. Should you encounter this issue, please contact your local Toro Distributor for assistance in replacing the plunger.
