Customer Service Bulletin Commercial Business Group

Reelmaster® 3100-D

Date: September 29, 2003

Subject: **Lift intermittently fails to hold, allowing cutting units to fall.**

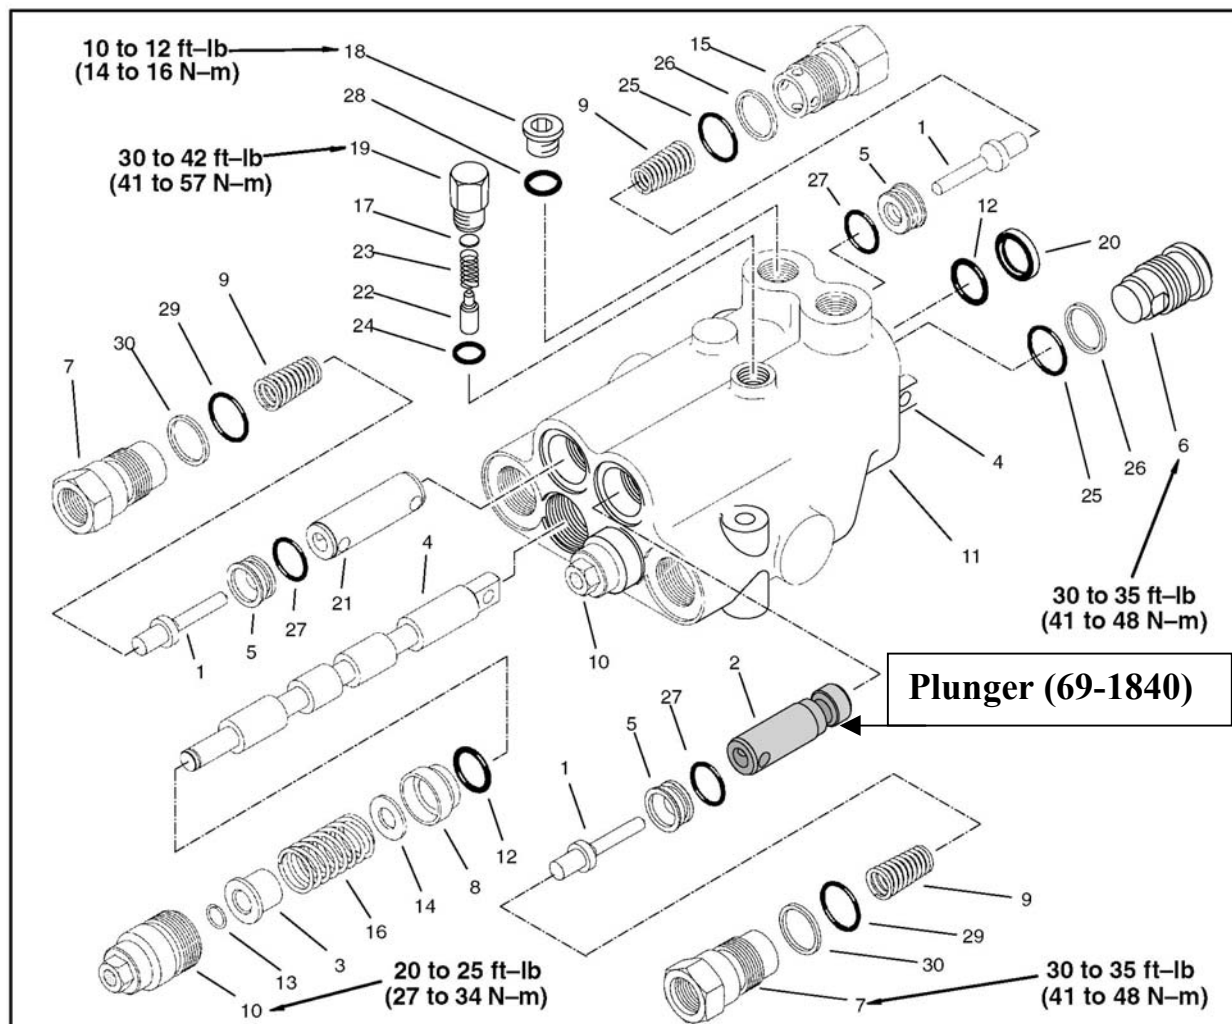
The Plunger (69-1840) in Control Valve Assembly (95-8581) may have been machined improperly. An improperly machined plunger may intermittently allow the cutting units to drop as soon as the lift handle is released. Should you encounter this issue, please contact your local Toro Distributor for assistance in replacing the plunger.
