Customer Service Bulletin Commercial Business Group

Reelmaster® 5200-D and 5400-D

Date: August 13, 2004

Subject: Lift arms restrict the ground following capabilities of the cutting units.

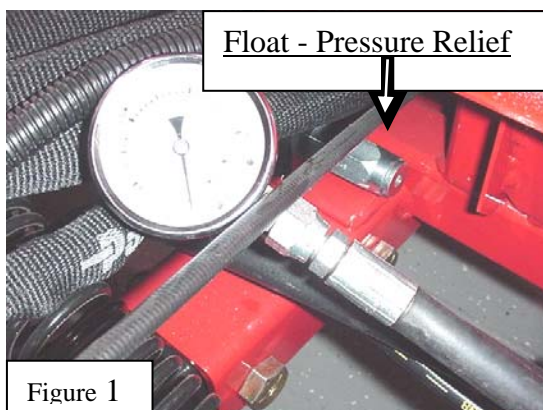
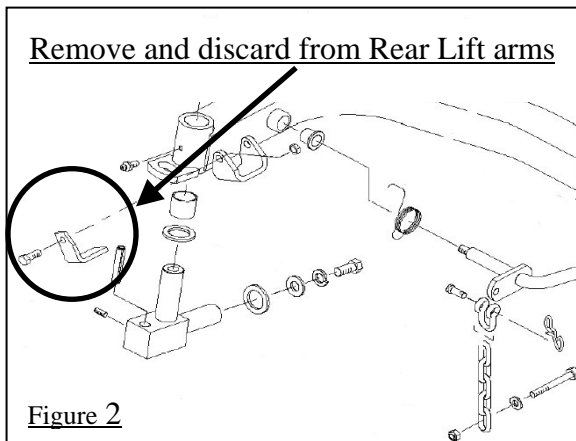
The rotation of the rear cutting units from side to side is restricted by brackets that may have been erroneously installed on the rear lift arms.

Stop RH (93-3640) and Stop LH (83-5170) are not necessary for these units and should be removed and discarded whenever convenient or if any quality of cut issues arise from mismatched cutting units.
