RE: Leaf Spring Clamp - Rework

Multi Pro® 5700

SPRING PLATE REPLACEMENT INSTRUCTIONS

For Multi Pro 5700

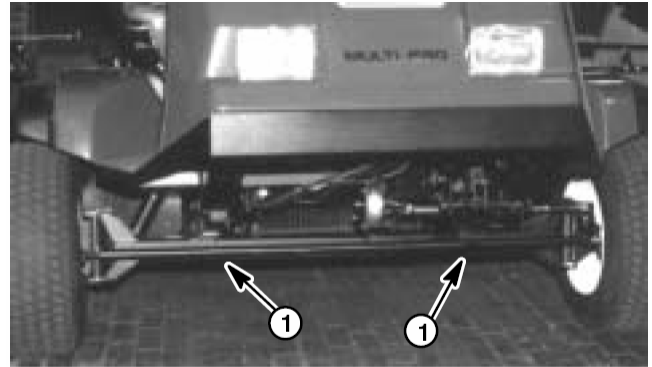
Figure 1

1. Front jacking points

1. Park the machine on a level work surface, apply the parking brake, turn the engine off and remove the key.
2. Block or chock the rear wheels to prevent the machine from moving.
3. Raise the front end and place jack stands under the front axle. (Figure 1)

Note: Do not place the jack stands under the spring plate or axle attachment hardware.

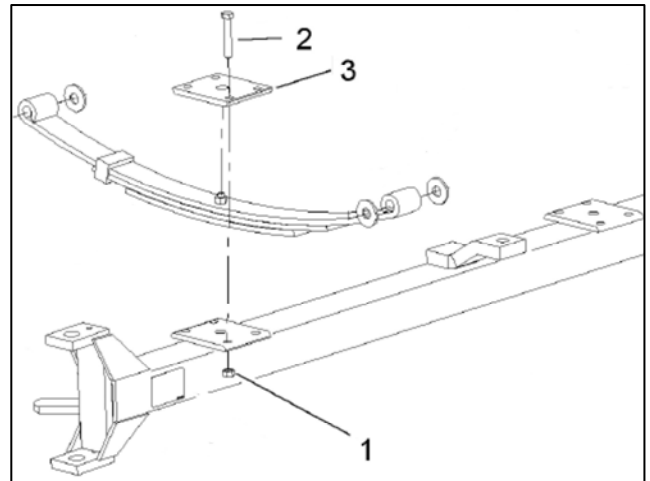
Figure 2

1. Lock Nut 2. Bolt 3. Spring Plate

4. Remove the axle hardware and spring plate from one side of the front axle. (Figure 2)
5. Install Spring Plate (112-7822-03) using four Bolts (323-45) and four Lock Nuts (32153-2) as depicted in Figure 2.

Note: Apply Loctite 242 or equivalent to the bolt threads prior to installation.

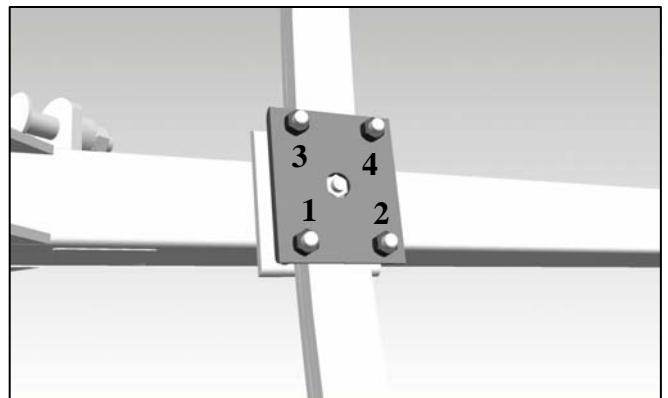
Figure 3

Torque sequence - cross pattern

6. Torque the bolts in two stages
 - a. Torque to 35 ft-lbs in the sequence described in Figure 3.
 - b. Torque to 53 ft-lbs in the sequence described in Figure 3. Double check that the torque has been attained by following the sequence twice.
7. Repeat steps 4 through 6 for the other side.
8. Remove jack stands and lower machine to the ground.
9. Adjust toe-in to 0 - 1/8 inch.
10. Test drive unit to verify the steering functions properly.
