## **Battery and Cable Inspection & Rework**

**Product: Groundsmaster® 4500 & 4700-D**

**May 16, 2007**

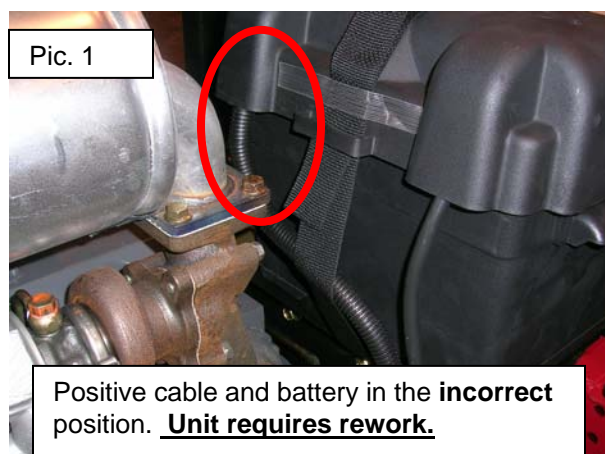
The battery and cables may be installed incorrectly on some Groundsmaster 4500 & 4700-D units. Incorrect installation places the positive battery terminal and cable too close to the Turbocharger & Exhaust Manifold and contact may only be prevented by the battery Case Strap. If the Strap fails (or cable not retained by strap) the positive cable could move and contact the exhaust manifold, resulting in a severe electrical short.

1. Raise Hood and visually inspect the Battery Case and Cable positions. If the battery positive cable (corrugated covering) is closer to the Turbocharger/Exhaust Manifold than the negative cable (Pic.1), then proceed with the rework.
2. If the negative cable is closer to the Turbocharger/Exhaust Manifold (Pic. 2) then no rework is required. Machine has been inspected.

If the battery's positive Cable is positioned next to the Turbocharger & Exhaust Manifold (as shown in Pic. 1 of the Inspection and Rework Instructions) the Battery must be lifted and rotated 180° so the positive post & cable will be away from these components (as shown in Pic. 2). The battery cables then must be repositioned to complete the rework. Secure Battery and Case with original Strap. All machines must be inspected and corrected if the battery and cables are found to be installed in the incorrect position. No additional parts are required to complete this procedure.

1. Remove Battery Case cover.
2. Disconnect negative Battery Cable. Disconnect positive Cable. Place cables off to the sides of the battery case.
3. Lift Battery Case (and Battery) and rotate 180° so the positive battery post is now away from the Turbocharger/Exhaust Manifold (Pic. 2).
4. Remove the retainer bolt and nut that secure the cable clamps at the base of the battery stand (Pic. 3). Swap the clamps from the cables and re-position so the positive cable is now nearest the main Frame of the machine (as shown).
5. Replace the retainer bolt and nut and tighten.
6. Re-install the positive Cable onto the positive Battery Post (in new position). Re-install the negative Cable and tighten post clamps.
7. Re-install the battery cover and secure with original Strap. **Note:** If strap is missing or failed, install replacement Strap (3339-175). Rework complete.
