## Contour Decks Develop Cracks at Discharge Area

**Product:** Groundsmaster 3500/3505 & 4500/4700-D Decks

**January 21, 2009**

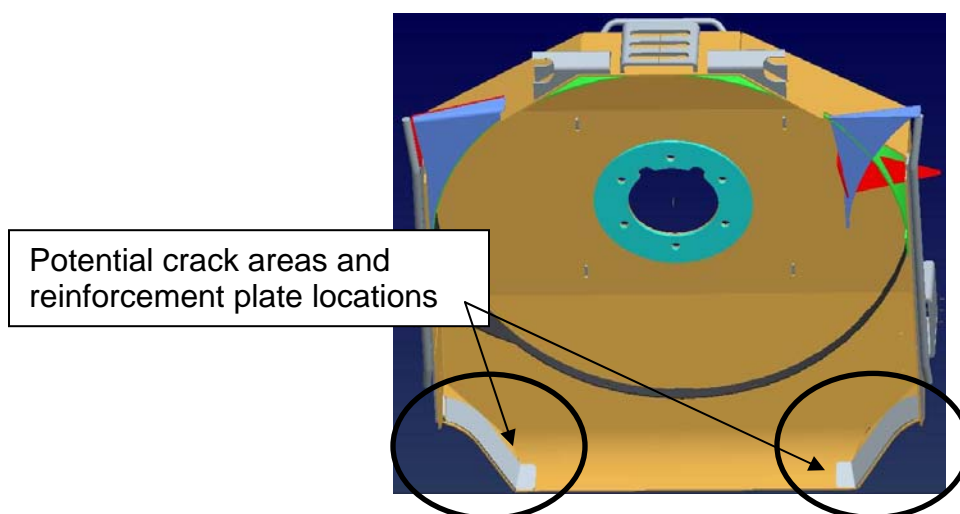
Some model year 2006 Contour 27" rotary decks may develop cracks in the deck housings at the rear discharge area. These cracks occur at the rear corners where the deck turns downwards (refer to picture) and are generally due to heavy discharge volumes and/or impact from debris processed by the deck during mowing (i.e. rocks, golf balls, etc.)

If cracking occurs at the back of a 2006 deck, the deck shell does not need to be replaced. Decks can be repaired by welding the shell and installing Deck Corner reinforcement Plates (110-8780-01 & 110-8781-01). These weld-in reinforcement plates will strengthen the deck corners and prevent the problem from reoccurring.
