## Lift Arm Pivot Hardware Loosens

**Product:** Reelmaster 5010 Series

**June 26, 2009**

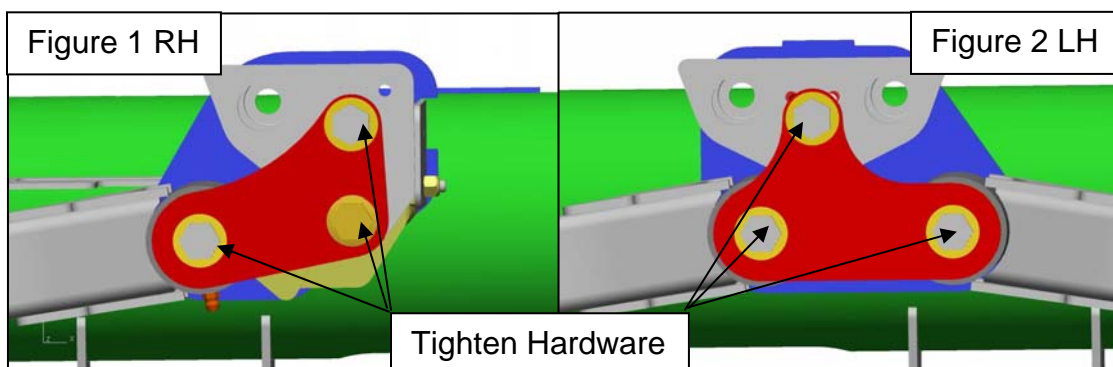
Hardware that retains the lift arm Pivot Pins can loosen over time. (Figure 1 RH and Figure 2 LH)

Check and tighten hardware to 85 ft-lbs (115 N-m) as required during normal maintenance or every 50 hrs of operation. Failure to maintain proper hardware torque will result in worn end plates, pins and hardware which could eventually lead to frame breakage.
