Lift Arm Pivot Hardware Loosens Repeatedly

Product: Reelmaster 5010 Series

April 3, 2010

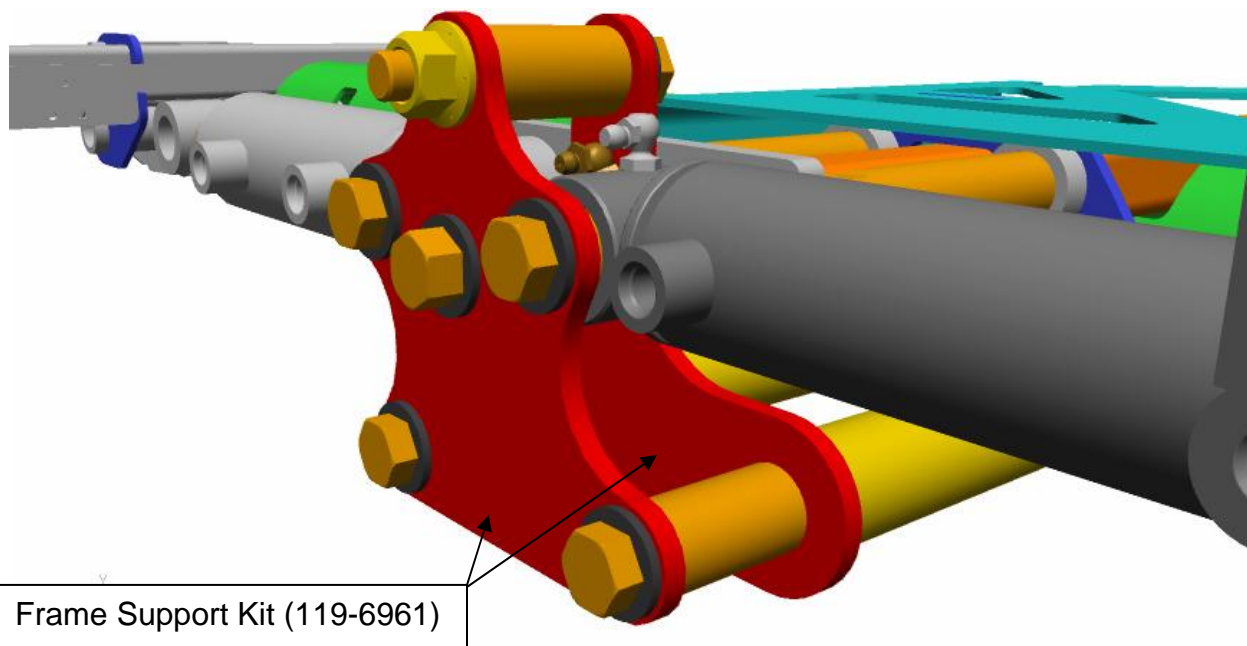
The hardware that retains #1 and #4 lift arms can become loose. This hardware must remain tight. Service Bulletin Large Reels #02-09 addresses the issue of loosening hardware and the need to periodically verify hardware torque. In some instances components may have worn, which can allow hardware to loosen more frequently.

A kit has been developed to reinforce this area which resists movements that lead to hardware loosening. When repairs are being made to this area, the use of Frame Support Kit (119-6961) is recommended.
