Deck Idler Repair Weldment

Product: Groundsmaster® Guardian Recycler 72" Deck

July 21, 2011

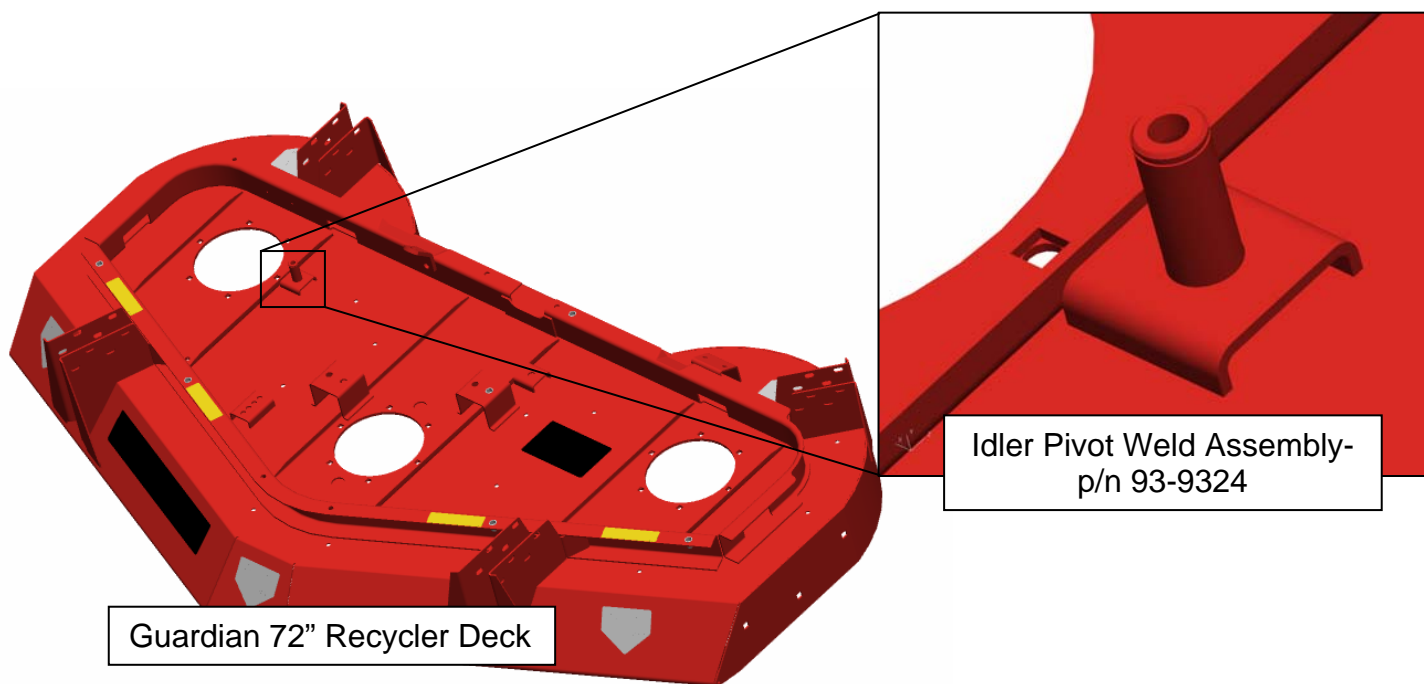
A service part weldment Idler Pivot Weld Assembly (93-9324) is available to repair failed deck belt idler pivot shafts. Use of this part will prevent deck replacement if this pivot shaft were to seize and fail.

1. Remove the deck belt cover, belt and Idler Pivot Assembly from the deck.
2. Use a center punch and hammer to mark the 4 corners of the original bracket location.
3. Grind the original Idler Pivot Assembly off of the deck.
4. Weld the service part bracket within the 4 punch marks.
5. Paint the welded area of the assembly to prevent corrosion.
6. Re-assemble the Idler arm and re-install the deck belt.
