## **Rattle Noise from Engine Bay**

**Product: Workman® MD & MDX**

**Aug 23, 2012**

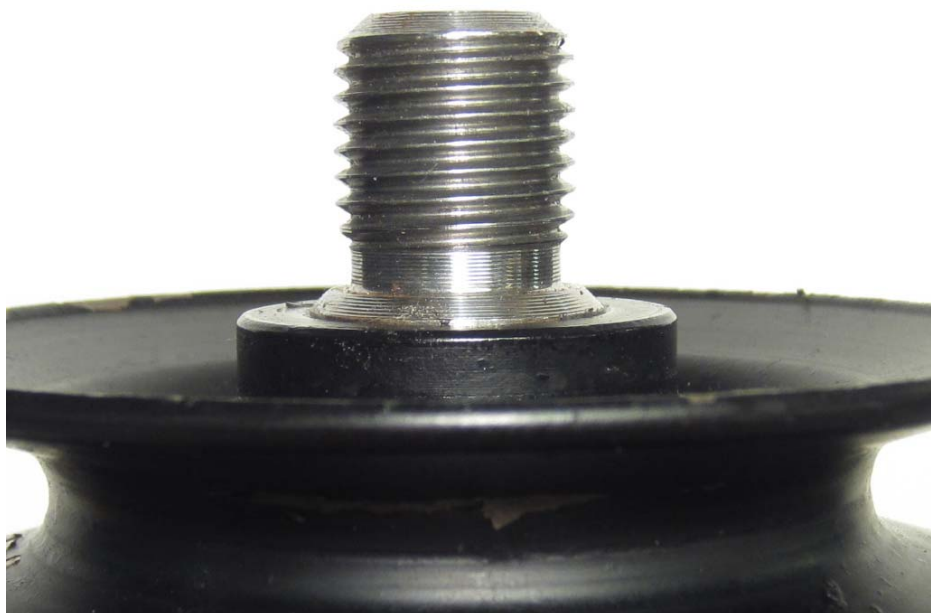
A rattling noise coming from the engine bay area may be caused by the Starter / Generator (S/G) Pulley – Drive (119-9482) not being secured by the torqued nut. It has been determined that the hub of the Pulley can be too thin (see image below) which causes the S/G Nut (119-9651) to bottom out on the taper of the Armature shaft of the S/G before it can secure the Pulley. This loose Pulley can then wobble, and make a rattling noise.

Workman MD/MDX Service Manual). Inspect the Pulley for any damage. If damage is present, replace the Pulley with Pulley – Drive (121-6277) which has a thicker hub.

If in doubt about the fit of the original Pulley (119-9482), add an 11/16" I.D. Washer / Spacer (107-4293) onto the starter shaft before the S/G Pulley, and reinstall the S/G Washer-Lock (119-9652) & Nut (119-9651). Torque the nut to **15 to 25 ft. – lbs. (21 to 33 N-m)**.
