Carburetor Sediment Bowl Breaks When Removed

Product: Greensmaster® Walk Mowers

January 17, 2014

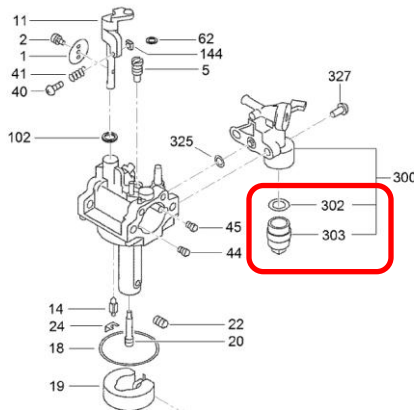
Removing the fuel sediment bowl can result in fracture of that plastic component. (Item 303)

The engine manufacturer is evaluating the issue and modifications are pending. As an interim resolution, it is recommended to use a 12 point 17 mm socket to remove the cup for inspect and maintenance process. Tightening method: Temporarily (hand) tighten for 2 to 3 rotations, then tighten by low range torque wrench. The torque spec is: 15.9 in/lbf ± 2.65 in/lbf (1.8 Nm +/- 0.3 Nm)
