Reelmaster® 216

Subject: When traction unit is in motion the cutting units may not lift.

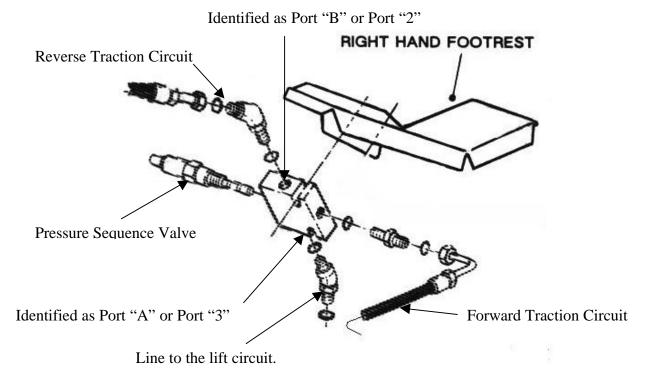
The cutting unit lift system may not function effectively while the traction unit is in motion if Hydraulic Valve Assembly (63-5080) is installed improperly. This condition becomes more noticeable as the hydraulic system wears and becomes less efficient over time.

If this symptom occurs, use the illustration below to verify the correct installation of Hydraulic Valve Assembly (63-5080). Incorrect installation of this Hydraulic Valve Assembly does not have any long-term affects on the hydraulic system or components. If you still are experiencing a no lift situation, the integrity of the units hydraulic system should be checked.
