Customer Service Bulletin Commercial Business Group

Reelmaster® 223-D and 5100-D

Subject: **Cutting Unit Stop Pin (roll pin) shears or falls out.**

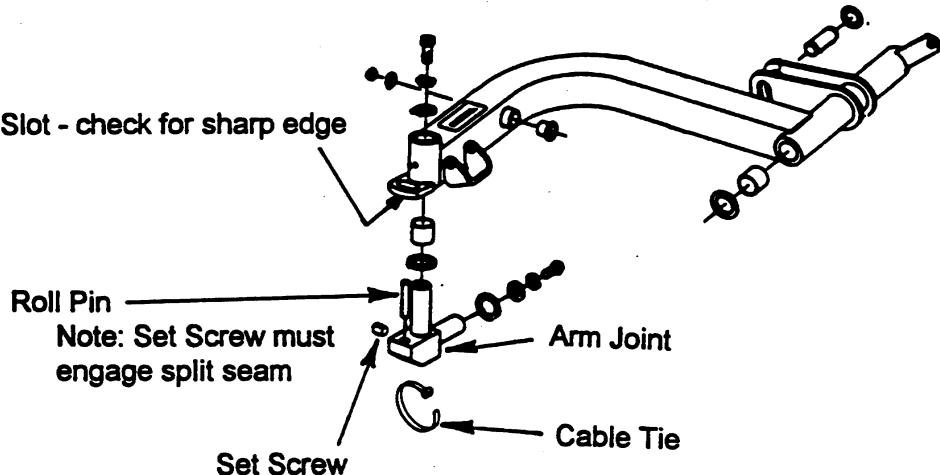
The roll pin is a protection device designed to shear if the Cutting Unit strikes an object. If the roll pin fails, it may be performing as designed. However, there are other factors that may contribute to a failure of the roll pin. Listed below are some potential causes.

- A. The punched slot in the lift arm may have a sharp edge on the bottom surface. A sharp edge can cause the pin to shear when it suddenly bottoms out.
- B. Lowering the Cutting Units to the ground while turning can exert enough force to damage or deflect the roll pin.
- C. Driving of the machine at transport speeds over rough terrain without the cutting units fully raised (switch in "Enable"), may cause damage to the roll pin.

1. Always install a roll pin with the split seam facing the end of the slot. Install Cable Tie (3290-378) through the center of the roll pin.
2. Remove any sharp edges from the bottom of the slot (file or grind).
3. Train operators to reduce speed in rough terrain and avoid lowering the cutting units while in the process of turning. Drop cutting units only while moving straight ahead.
4. Train the operator to transport in the "Enable" mode between cutting areas so the cutting units are in a fully raised position.
5. Drill a 13/64" (5.1mm) hole in the side of the Arm Joint as noted in the diagram. Thread the hole with a 1/4-20 UNC Tap. Install Set Screw (92-9097) into the threaded hole so that it contacts the split seam of the roll pin.

NOTE: Arm Joint (75-3010) used on current products include this modification.
