Greensmaster® Flex 21 Cutting Unit Date: November 20, 2003

Subject: Uneven contact between reel and bedknife.

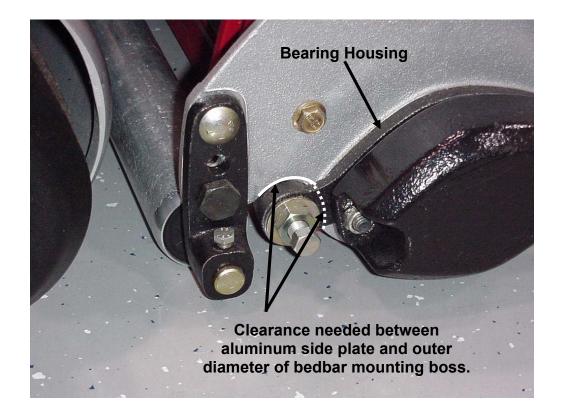
A missed machining operation on some cutting unit frames may prevent proper alignment of the reel bearing housings. This condition can prevent the front edge of the bedknife and reel from making proper contact. Performance of the unit will be affected and a poor quality of cut may result.

If uneven contact or a poor quality of cut is noticed, inspect for clearance between the bedbar mounting boss of the Bearing Housing and the cutting unit Side Plates. If contact is noted, a small amount of aluminum material will need to be removed from the Side Plate to eliminate the interference.

Some disassembly is required to perform this repair. Contact your Toro Commercial Products Distributor if assistance with this procedure is needed.
