## All Products that Utilize a Drive Coupler Disk Assembly

**Date:** October 30, 2006

### **Subject: Correct Drive Coupler Assembly Installation and Orientation**

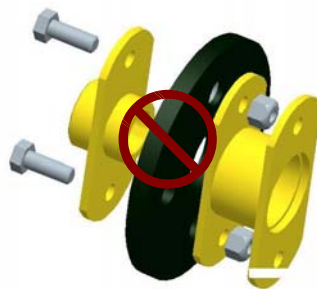
Incorrect Drive Coupler Installation shown on top picture: The Drive and Driven Coupler are incorrectly installed in-line.

During repair of a Toro Product with any Drive Coupler Assembly, the installation orientation of the assembly should be verified for proper installation of coupler and hub; the proper orientation for the Drive Coupler Assembly is at ninety degrees apart.

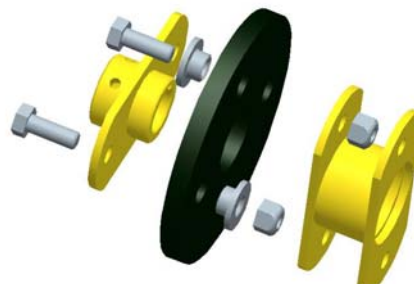
Correct Drive Coupler Installation on the picture below: The Drive and Driven Coupler are installed ninety degrees apart from one another.
