# Customer Service Bulletin Commercial Business Group

## Workman® 3000/4000 Vehicles

### Subject: Deformed and Cracked Seat Base

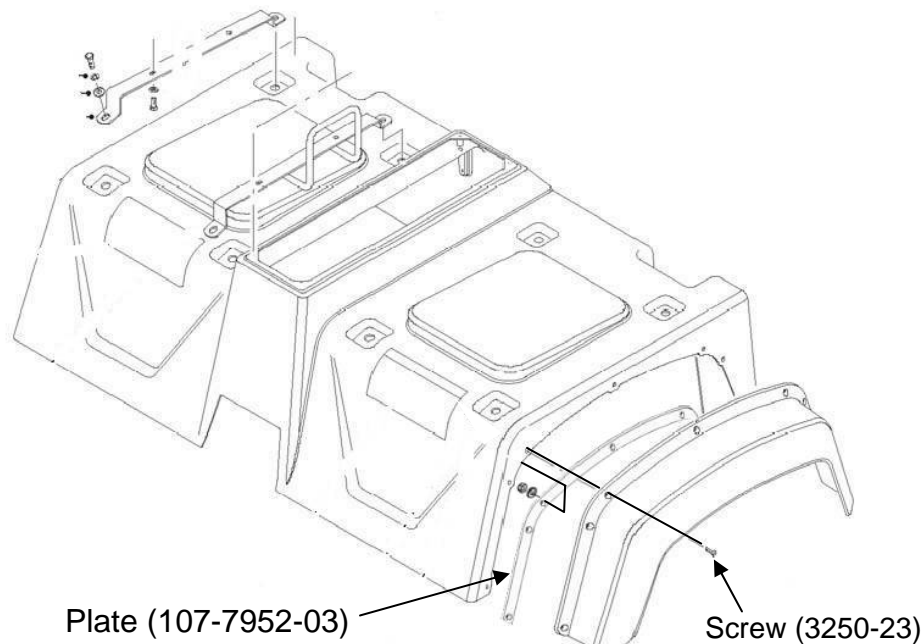
The seat base may deform over time and cause the fender to separate from the mounting surface. Reinforcement Plate (107-7952-03) is now available and may be added to the inside of the seat base to draw the area flat. Even if some damage to the seat base is present, the clamping force of the assembly and the remaining integrity of the seat base will be sufficient to salvage the seat base. Screw (3250-23) is suggested to replace the existing screws, as it is slightly longer to accommodate the thickness of the added plate and eases assembly of the warped parts. The picture below highlights the area involved.
