Customer Service Bulletin
Commercial Business Group

Sand Pro® 5020 May 9, 2002

Subject: Engine will not crank due to a failed Starter Solenoid.

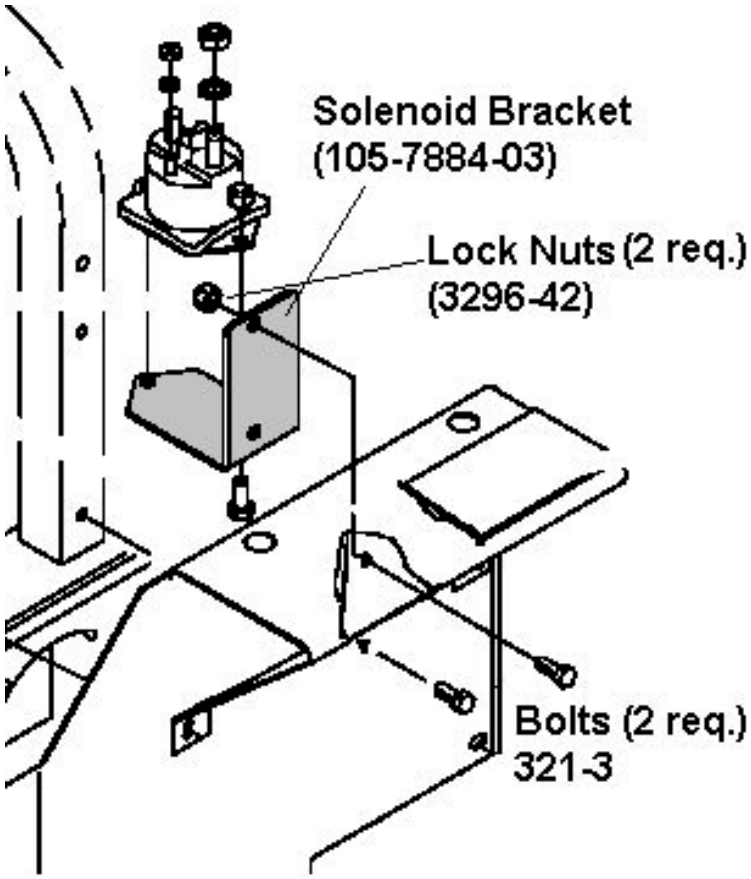
The engine may not crank (no starter engagement) due to a failed Starter Solenoid (28-4210). If a Starter Solenoid fails on a unit listed, it is recommended that a new Solenoid be installed utilizing a Solenoid Bracket (105-7884-03). The bracket repositions the Solenoid to a horizontal position, which would improve Solenoid durability.

To install, disconnect the Battery. Remove Starter Solenoid and install the Bracket to the Frame using the original Solenoid mounting holes and additional retaining hardware listed. Install the Solenoid to the Bracket as shown.
