## **Battery and Cable Inspection & Rework**

**Product: Groundsmaster® 4500 & 4700-D**

**May 16, 2007**

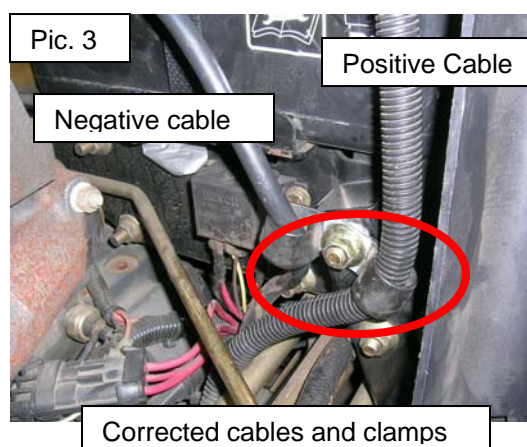
1. Raise Hood and visually inspect the Battery Case and Cable positions. If the battery positive cable (corrugated covering) is closer to the Turbocharger/Exhaust Manifold than the negative cable (Pic.1), then proceed with the rework.
2. If the negative cable is closer to the Turbocharger/Exhaust Manifold (Pic. 2) then no rework is required. Machine has been inspected.

1. Remove Battery Case cover.
2. Disconnect negative Battery Cable. Disconnect positive Cable. Place cables off to the sides of the battery case.
3. Lift Battery Case (and Battery) and rotate 180° so the positive battery post is now away from the Turbocharger/Exhaust Manifold (Pic. 2).
4. Remove the retainer bolt and nut that secure the cable clamps at the base of the battery stand (Pic. 3). Swap the clamps from the cables and re-position so the positive cable is now nearest the main Frame of the machine (as shown).
5. Replace the retainer bolt and nut and tighten.
6. Re-install the positive Cable onto the positive Battery Post (in new position). Re-install the negative Cable and tighten post clamps.
7. Re-install the battery cover and secure with original Strap. **Note:** If strap is missing or failed, install replacement Strap (3339-175). Rework complete.
