Customer Service Bulletin Commercial Business Group

Reelmaster® 5500-D

Subject: Leakdown of lift arms due to a Blocking Cartridge leaking internally.

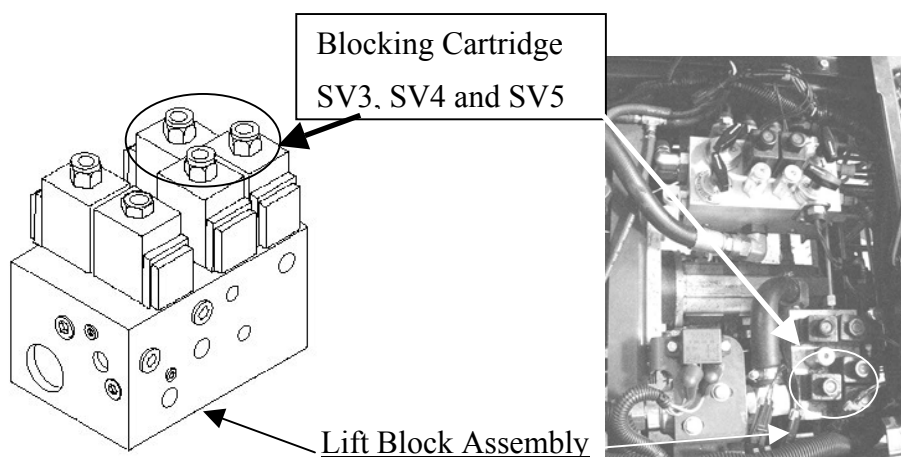
Internal leakage through the SV3, SV4 or SV5 Blocking Cartridges (104-1208) may allow the related cutting units to leakdown, or lower to the ground without activating the controls. Some leakage through this cartridge is normal and can allow the ram to extend up to 5/8 in. (16 mm) per hour. It is good practice to lower all cutting units completely when the machine will be parked for more than two hours.

If any of the lift arms show signs of leakdown in excess of 5/8 in. (16 mm) per hour the associated cartridge should be replaced. Blocking Cartridges (104-1208) change to Cartridge Kit (104-9341). The installation of Cartridge Kit (104-9341) requires that the ECU be upgraded with software revision 105-8502 or newer. Contact your local distributor service department for assistance with the software upgrade.
