Customer Service Bulletin
Commercial Business Group

Greensmaster® Flex 21

Model/Serial Range:	Model Number:	Serial Numbers:
	04021	210000101-210001182

Subject: Cutting Unit contacts Traction Drum.

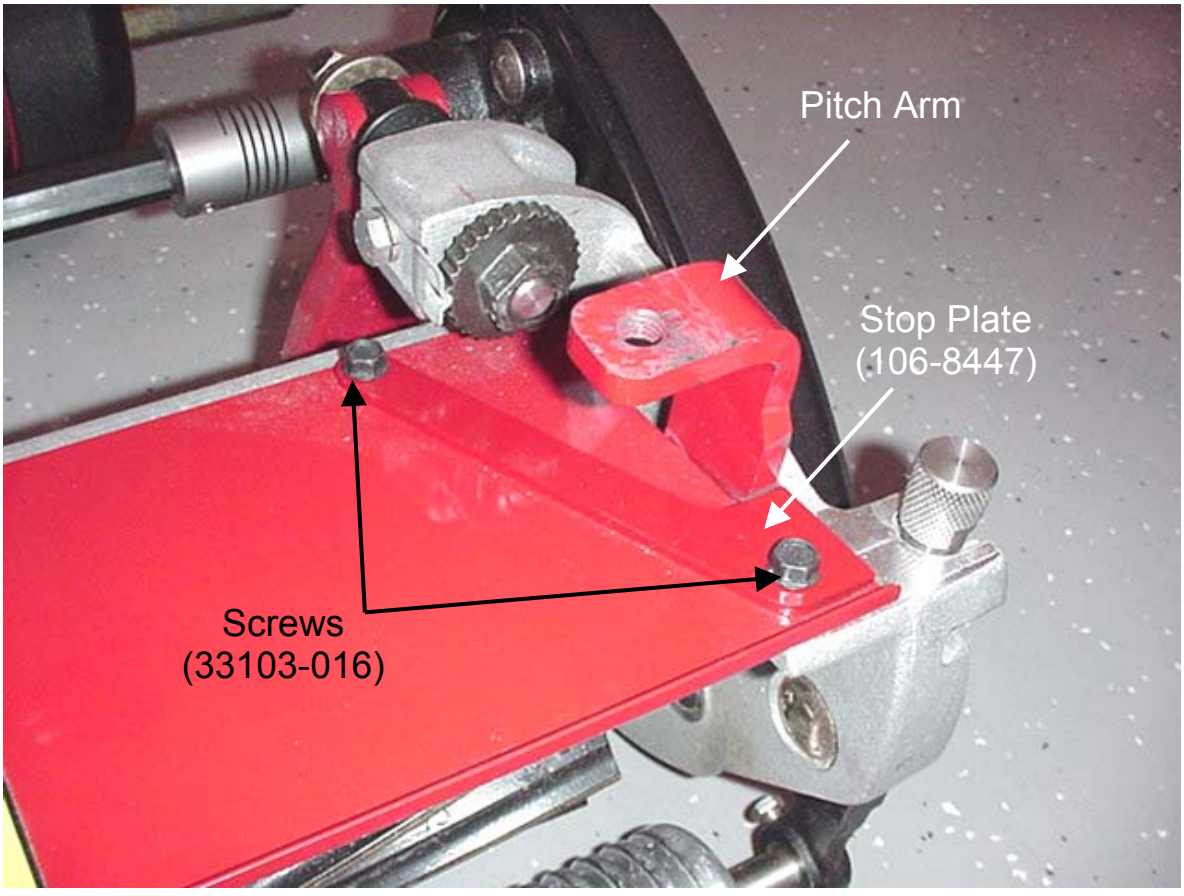
The left hand Pitch Arm (105-2448-01) may bend if the mower impacts solid objects (e.g., curb, trailer, etc.). This can allow the cutting unit to move rearward and contact the traction drum during operation. This condition causes no operating difficulty, but will mar the surface of the aluminum traction drum.

If contact is noted between the left side of the cutting unit and the traction drum, Stop Plate (106-8447) is available for installation. The Stop Plate strengthens the connection area to resist bending from impacts (e.g. loading into a trailer) and provides a limit for allowable rearward movement of the cutting unit. The Stop Plate uses existing mounting holes, however longer Screws (33103-016) are to be used for mounting.

If the left Pitch Arm is bent severely, replacement should be considered.
