Making The Cut

Comparing Genuine Toro® Parts To Will-Fit Parts

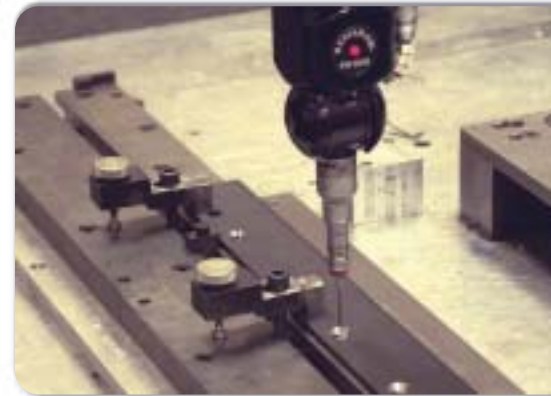
Toro performs exhaustive tests on bedknives and has found that genuine Toro parts are superior.

material make-up, micro-structure, micro-hardness and other characteristics,” Olson says, “We again found that the imitation knives did not meet design specs. It is not material that was designed and qualified for that system.”
