## Operator's Manual

MODEL NO. 30196 – 890001 & UP  
MODEL NO. 30197 – 890001 & UP

## ADDENDUM

### Adjust PTO Bellcrank

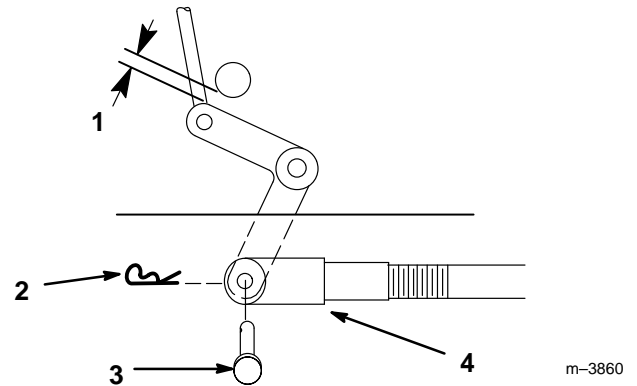
**Figure 1**

1. Engage PTO lever and check the clearance between the bellcrank and the axle shaft (Fig. 1). Space should be  $1/4''$  (6mm).
2. If adjustment is required, remove hairpin cotter and clevis pin from bellcrank. Rotate clevis clockwise on rod to increase or counterclockwise to decrease clearance (Fig. 1).

| 1. $1/4''$ (6mm) | 3. Clevis pin |
| 2. Hairpin cotter | 4. Clevis |
