## Operator's Manual

MODEL NO. 30196 – 890001 & UP  
MODEL NO. 30197 – 890001 & UP

## ADDENDUM

### Adjust PTO Bellcrank

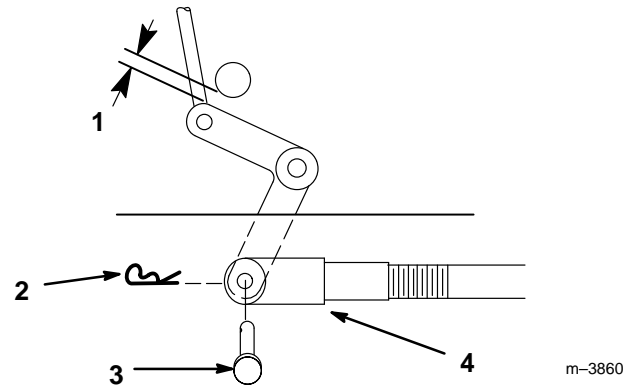
**Figure 1**

1. Engage PTO lever and check the clearance between the bellcrank and the axle shaft (Fig. 1). Space should be 1/4" (6mm).
2. If adjustment is required, remove hairpin cotter and clevis pin from bellcrank. Rotate clevis clockwise on rod to increase or counterclockwise to decrease clearance (Fig. 1).

| 1. 1/4" (6mm) | 3. Clevis pin |
| 2. Hairpin cotter | 4. Clevis |
