## Customer Service Bulletin Commercial Business Group

### Reelmaster® 335/3500/6500/6700-D and Groundsmaster® 455-D

**Subject: Hydraulic oil leaks past Motor Seal into 4wd Rear Axle.**

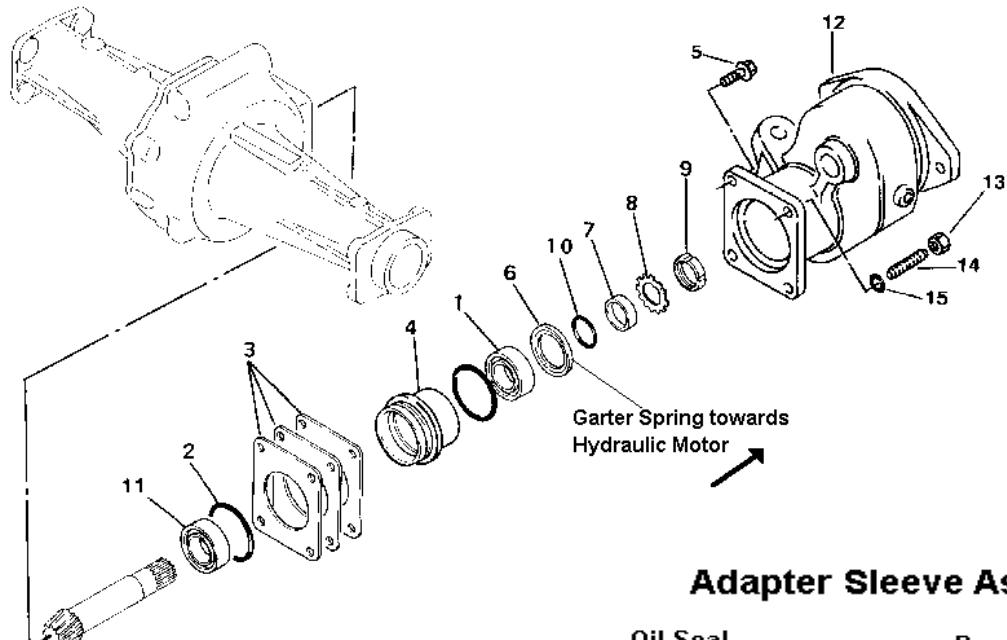
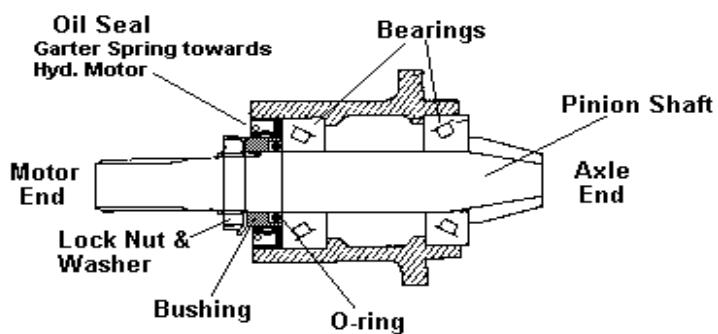
**Adapter Sleeve Assembly**

A revised diagram detailing proper parts and Seal orientation is shown below for your reference. Copies of this diagram are recommended to be inserted into all affected Service Manuals (Reelmaster 335/3500-D, 6500/6700-D and Groundsmaster 455-D) in section 6 - Axles and Brakes.

When installing Traction Drive Motor Seal (76-7340), be certain that it is positioned properly to prevent oil from entering the Axle. The Service Manual diagrams for proper Seal installation are vague. If this Seal is installed improperly, repetitive failures can result.
