Commercial Business Group

Greensmaster[®] 1000

04052

Subject: The Power Shaft may break due to over tensioning of the Drive Belt.

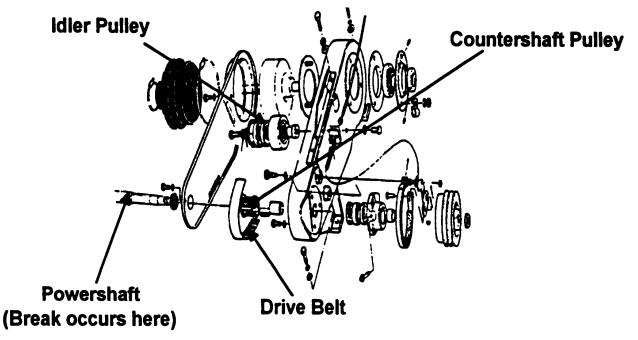
Differential Belt Adjustment Procedures for GREENSMASTER[®] 1000

- 1. Check tension by depressing the belt at mid span of pulleys with 5 lbs. (+/- 1 lb.) of force. The belt should deflect 1/4" (6.3 mm). If deflection is incorrect perform the following procedures.

- A. Remove capscrews securing front and rear sections of differential cover to differential housing and slide cover sections away to expose belt.
 - B. Loosen idler pulley mounting nut and pivot the idler pulley clockwise against the backside of the belt until the correct belt tension is attained.

- C. Tighten nut to retain adjustment.
 - D. Place belt cover in position. While maintaining a slight gap between the cover seal and the side plate, install each mounting bolt until the threads engage in the insert. The gap will allow visual alignment of the bolt to the threaded insert. Install all bolts, then tighten until the stand-offs inside the cover contact the side plate. Do not overtighten.
