Customer Service Bulletin Commercial Business Group

Reelmaster® 6500/6700-D

Subject: Engine Temperature Gauge Indicates Hot Engine Condition.

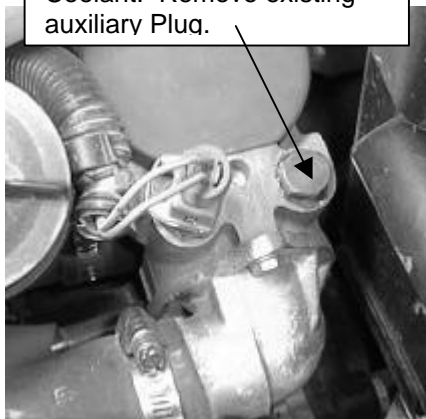
Machines (listed above) were produced with the Peugeot XUD9-AI version engine which uses a single, double function sending unit for the Temperature Gauge and overheat shut-down. The Gauge portion of the Sending Unit can be incorrectly matched to the Gauge, and can give inaccurate engine temperature readings. This can result in a Temperature Gauge needle that reads high in the green zone, in-between the green and red zone or slightly in the red during normal operation, even though the engine does not actually overheat or shut down.

1. Drain approx. a gallon of Coolant. Remove existing auxiliary Plug.
