## Customer Service Bulletin Commercial Business Group

### REELMASTER® 6500/6700-D

#### **Subject: Lift Arm Pivot Pin Capscrew Loosens or Backs Out**

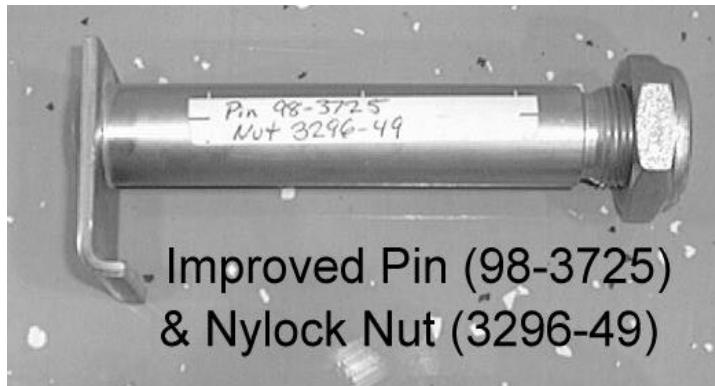
Pivot Pin (98-3725) and Nylock Nut (3296-49) are now available for replacement purposes, which eliminates the capscrew used in the original design. The replacement Pin features a stronger retainer Tab to better resist Pin rotation and has an increased length to allow for the threads of the Nylock Nut.

The Pivot Pin and Nylock Nut combination is a direct replacement for the original Pivot Pin. During installation, tighten the Nylock Nut sufficiently to remove Pivot Pin freeplay and movement. Avoid any over-tightening that might cause binding of the lift arm in the frame.

Pivot Pin (98-3725) and Nut (3296-49) are available through your local Toro distributor.
